**US Army Corps
of Engineers®**
Engineer Research and
Development Center

Evaluation of MegaSecur™ Flood Protection Barrier

Donald L. Ward

April 2015

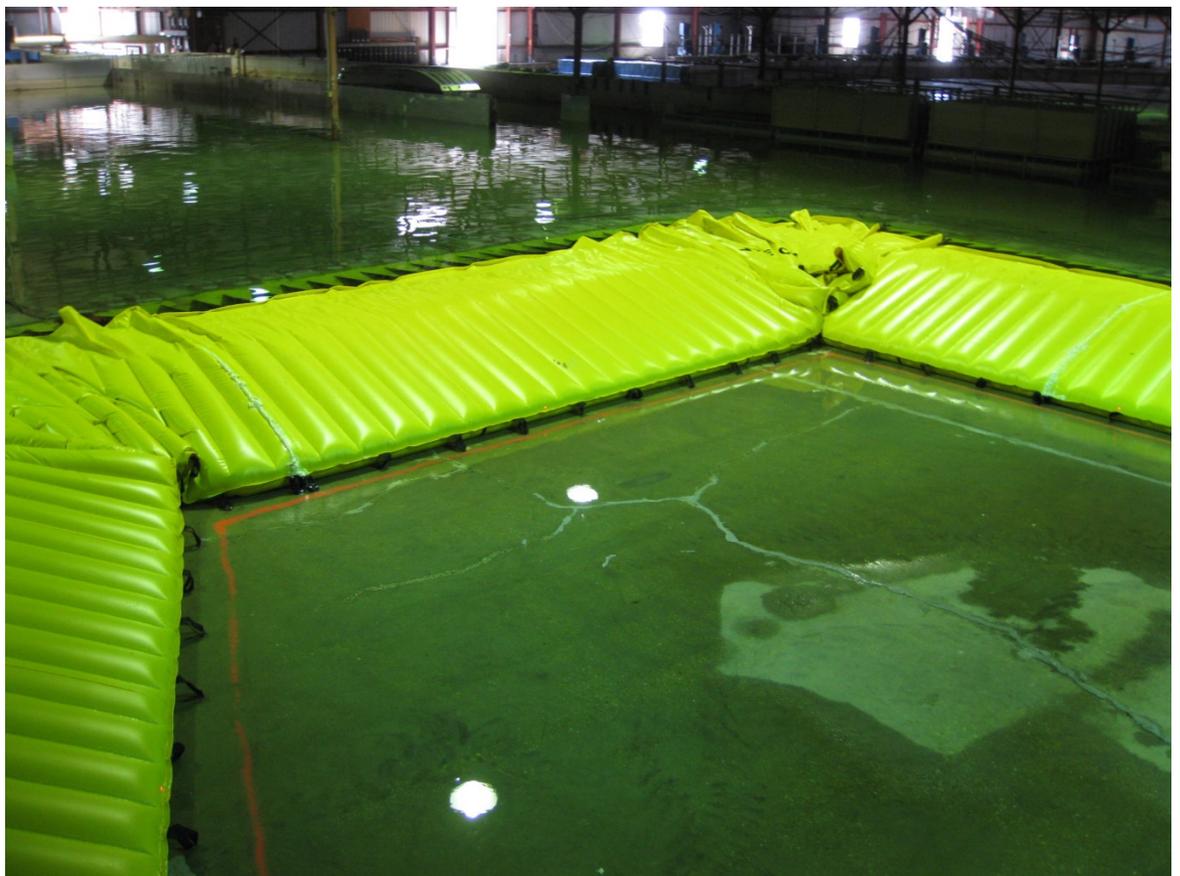
The MegaSecur™ flood protection barrier consists of two layers of heavy vinyl fabric joined at one edge to form a “V” lying on its side. One leg of the “V” lies on the ground; flotation in the leading edge of the upper leg causes the barrier to rise with rising flood waters. Vertical panels between the two legs of the “V” provide support.

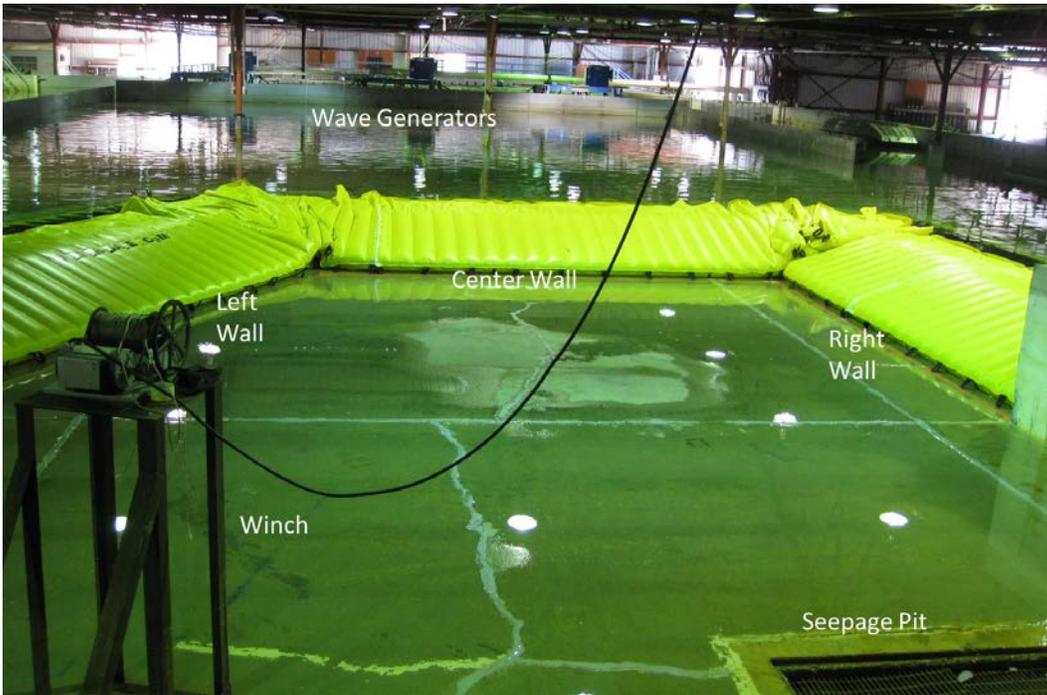
Figure 1. Looking into the research basin from the test area. The wave generators are at the far end of the basin, the winch for the debris impact test is lower left, and the seepage pit is to the lower right.

The test facility was laid out along the perimeter wall of a reservoir with dimensions of 115 ft by 185 ft by 4 ft deep (Figure 1). The test facility was reconfigured specifically for innovative flood-fighting experiments by allowing levees to be constructed against two wall abutments with a 30-ft opening between the walls (Figure 2). A geometric testing zone footprint was laid out on the concrete floor and all levees are required to be constructed within this given footprint. One side of the footprint abuts the concrete wall at a 90-deg angle, and the other side abuts the concrete wall at a 63-deg angle (Figure 3). The purpose for having two different angles is to simulate real-world geometric variability and demonstrate constructability and geometric flexibility of each vendor’s product. Additionally, the unsymmetrical geometry allows wave loading variability during hydrodynamic testing, and causes an apparent current along the 63-deg wall.

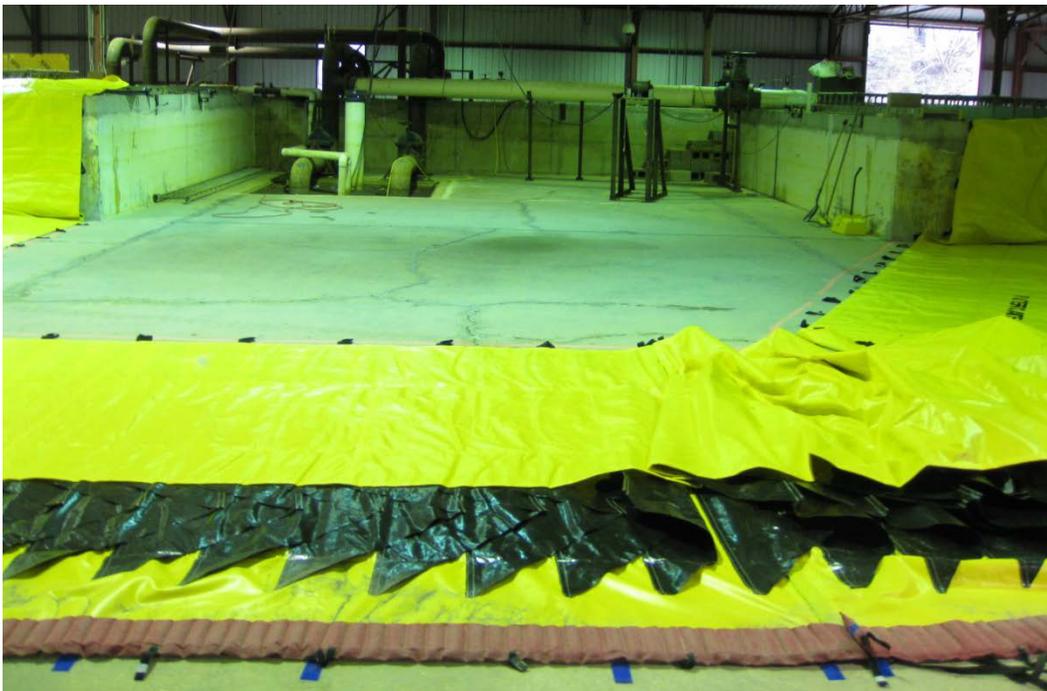
Figure 2. Looking into the test area of the research basin. The vertical white pipes extend down into the seepage pit.

Inside the test area (leeward side of the levee), an 8-ft diameter by 8-ft-deep circular pit was installed to catch any seepage or overflow water from the structure (Figure 3). Two 4-in.-diam pumps were installed in the seepage pit to pump the accumulated water back into the wave basin. Two 12-in.-diam pumps (12 in. intake and 10 in. output) were also installed to pump excess water out of the seepage pit when the capacity of the 4-in. pumps was exceeded.

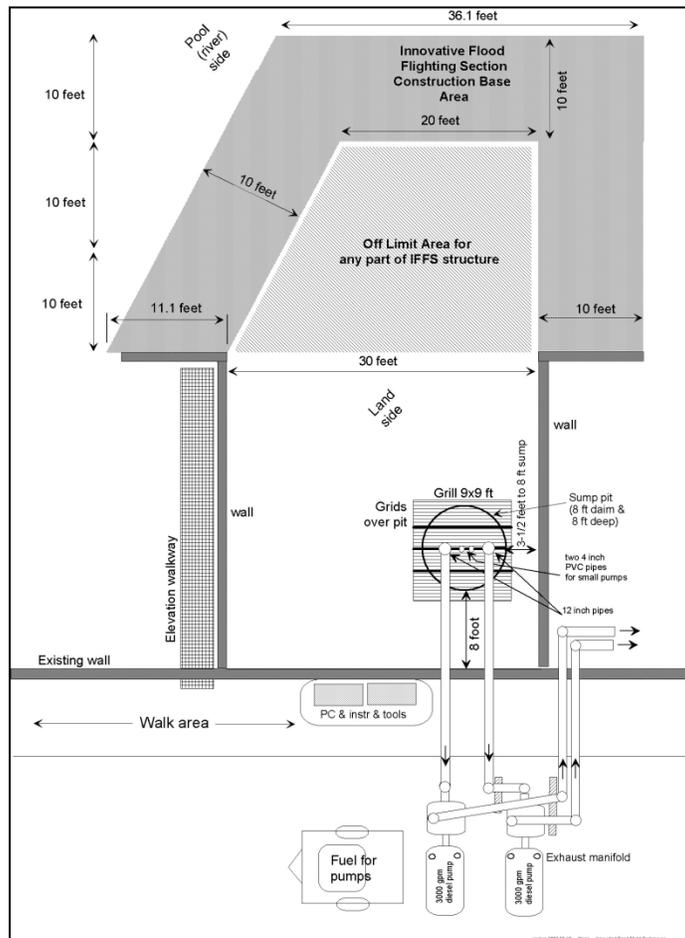
Figure 3. Layout of test area within research basin.

The test area was instrumented with a series of lasers to measure any movement of the flood-fighting barrier, a laser to measure changes in water surface elevation within the seepage pit, and an additional laser was placed to measure water surface elevation within the basin.

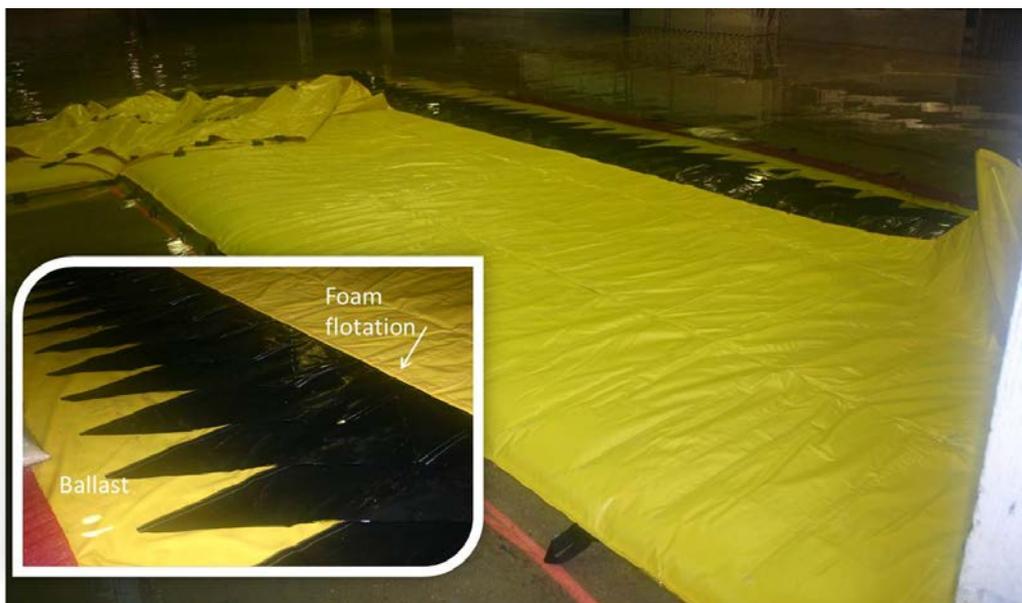
Figure 4. The barrier rising with the rising water level, from inside the test area. The insert shows the outer edge of the barrier looking in towards the test area.

The MegaSecur™ flood protection barrier is an innovative barrier made of heavy duty vinyl fabric that requires no assembly, filling, or anchoring. The barrier can be deployed simply by unrolling it in place, fastening multiple sections together with pre-attached Velcro fasteners, and securing the ends. As the flood waters come up onto the barrier, the weight of the water on the bottom layer holds the barrier in place and a strip of foam flotation in the upper layer causes the barrier to rise with the water level.

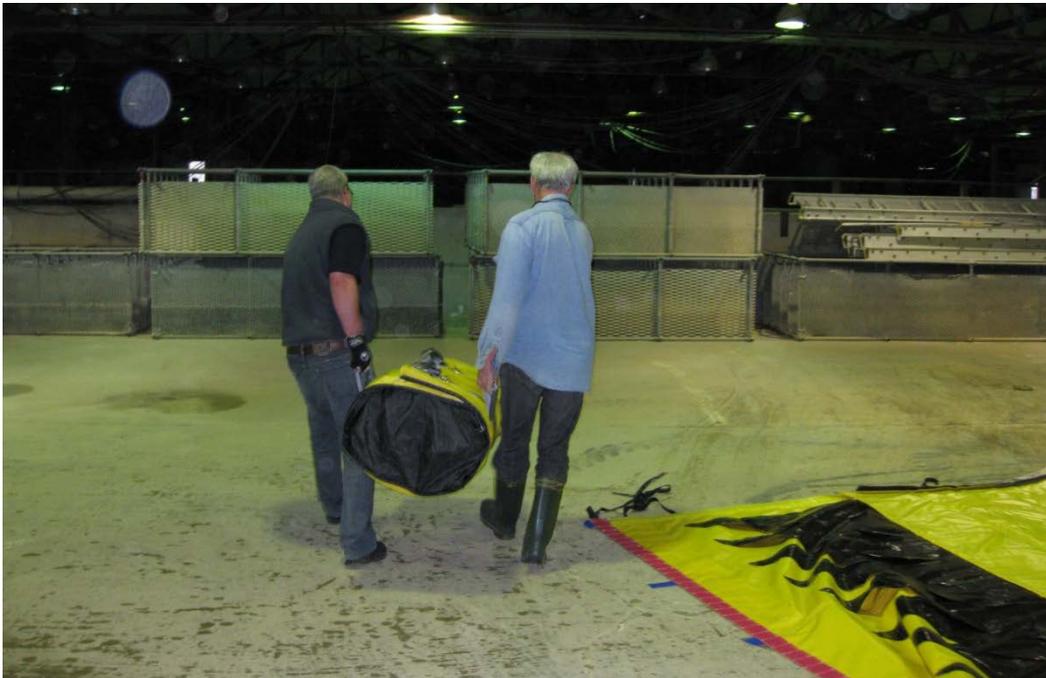
Figure 5. A 50-ft-long section of the barrier rolled up in its carrying case can be carried by two people.

Each section of barrier comes in a carrying case that can be easily handled by two people (Figure 5). The barrier is removed from the case, rolled out in place, and unfolded to its full size.

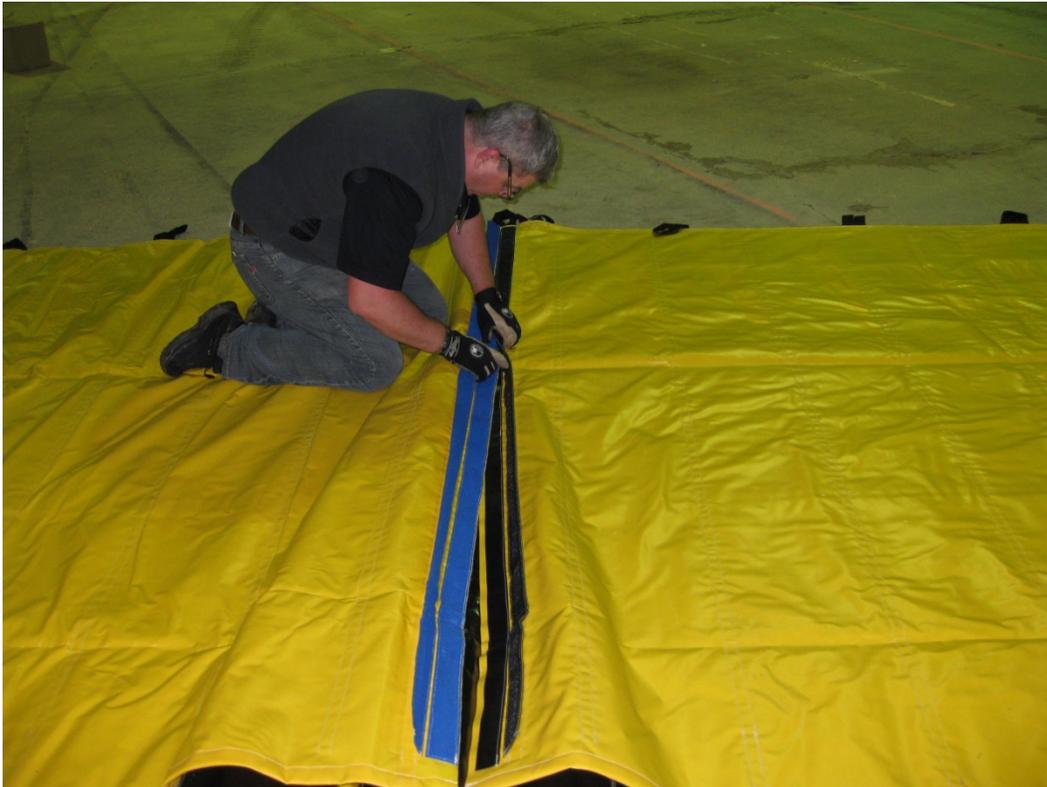
Figure 6. Adjacent sections of the barrier are fastened together with pre-attached double layers of Velcro fastener.

Adjacent units were fastened together with a double layer Velcro strip on both the top and bottom layers of the barrier (Figure 6).

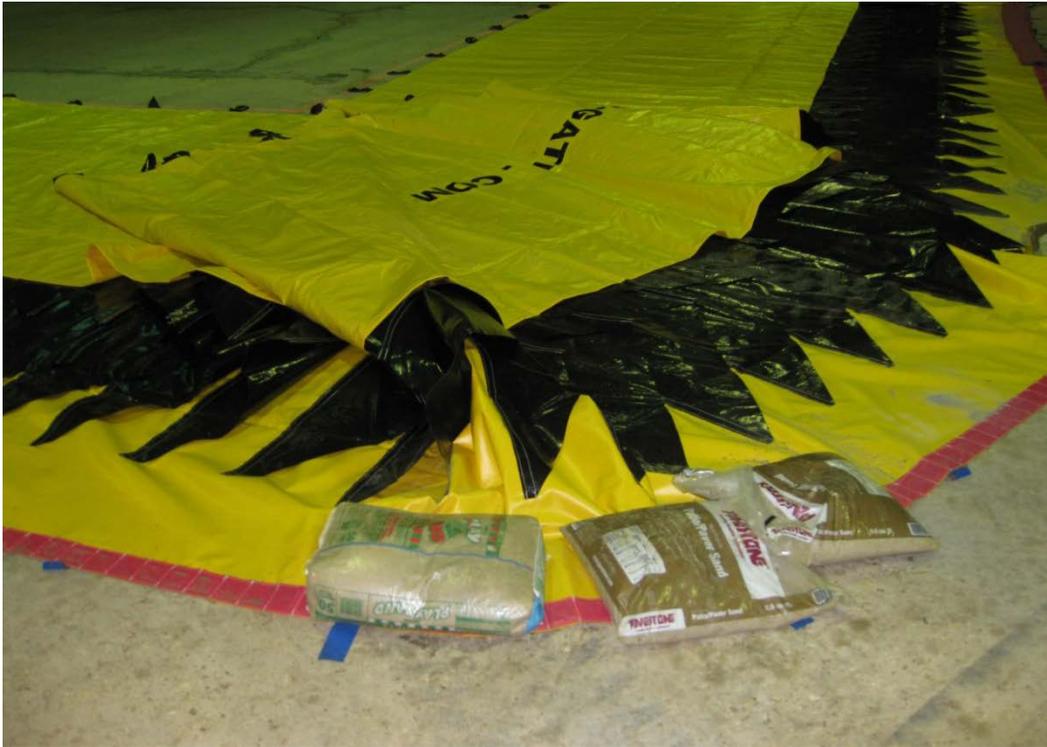
Figure 7. Corners were accomplished by simply folding the barrier.

The two corners in the planform of the Protocol (one 90 degree corner and one 63 degree) were accomplished by simply folding the barrier (Figure 7). Sandbags helped hold the edge in place while it was being folded.

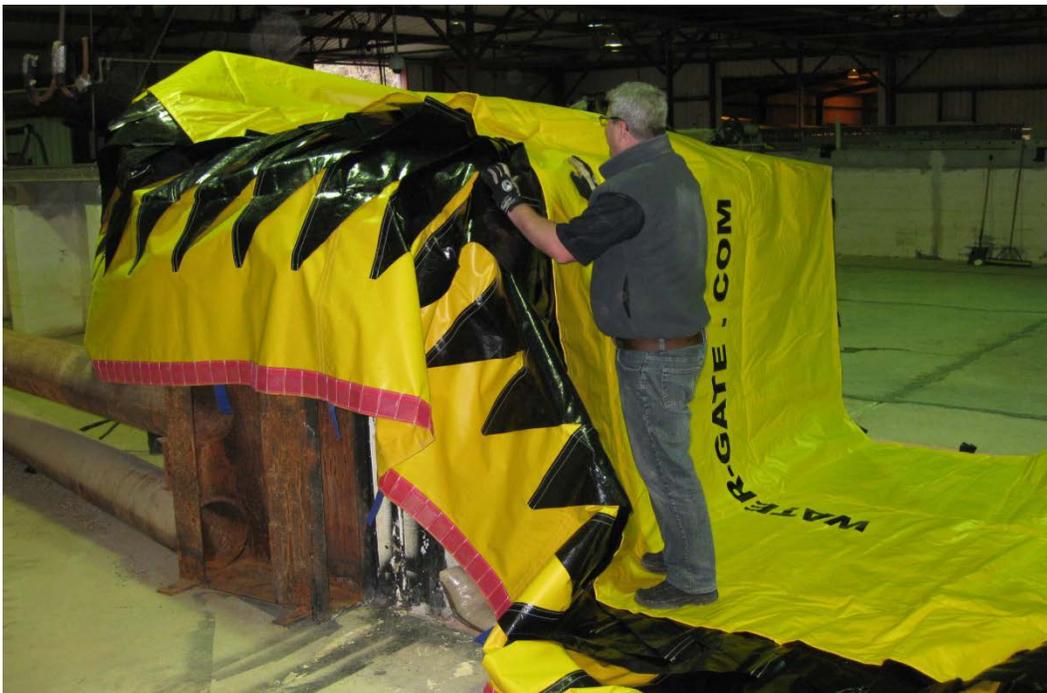
Figure 8. At the wingwalls, the barrier was just laid up over the wall.

At the wingwalls, the barrier was just laid up over the wall and anchored against the walls with some sandbags (Figure 8).

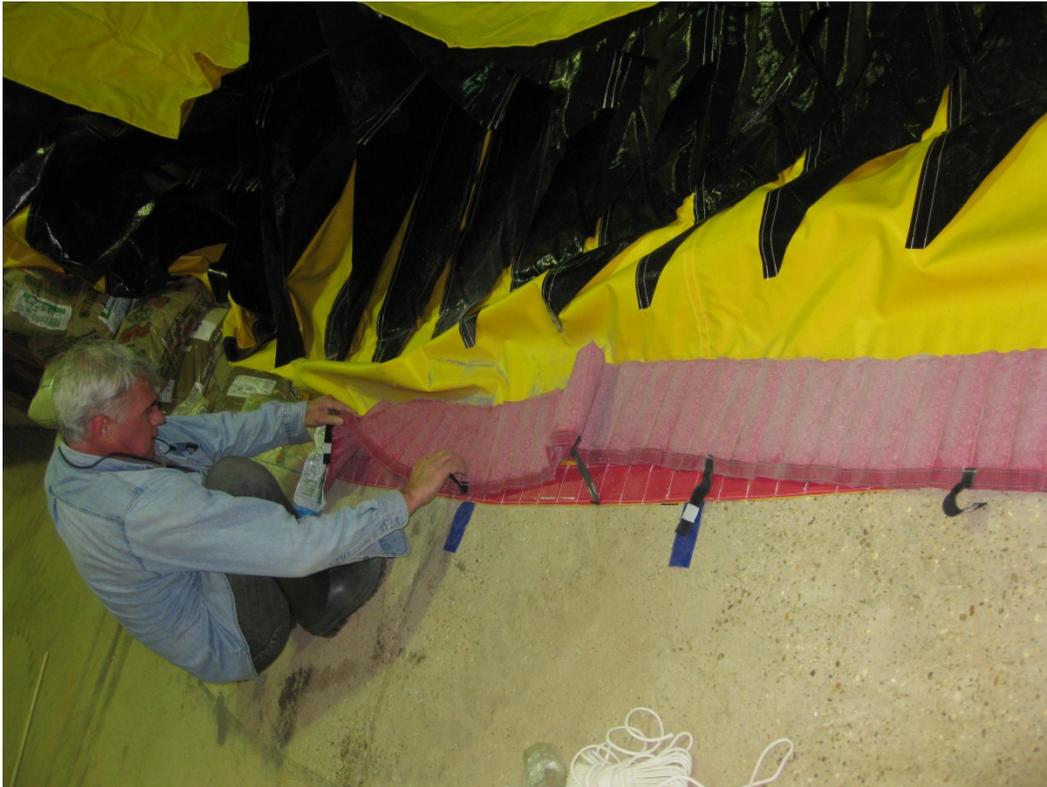
Figure 9. The pink fabric is a roll of pockets filled with small gravel to help hold down the outer edge of barrier.

A roll of fabric divided into segments and filled with small gravel is used to weight down the outer edge of the barrier (Figure 9). The darker red color beneath the pink roll of gravel in Figure 9 is a row of small metal weights sewn into the outer edge of the barrier.

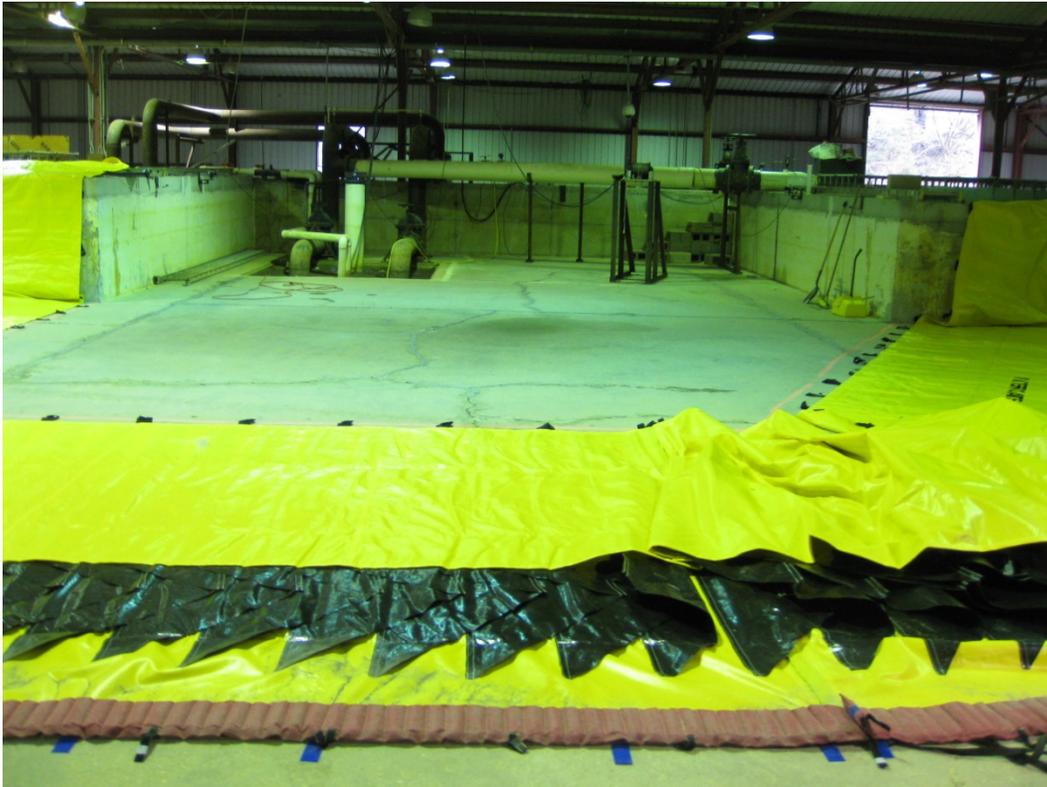
Figure 10. Completed typical installation, looking into the test area.

The completed barrier for a “typical” installation is shown in Figure 10.

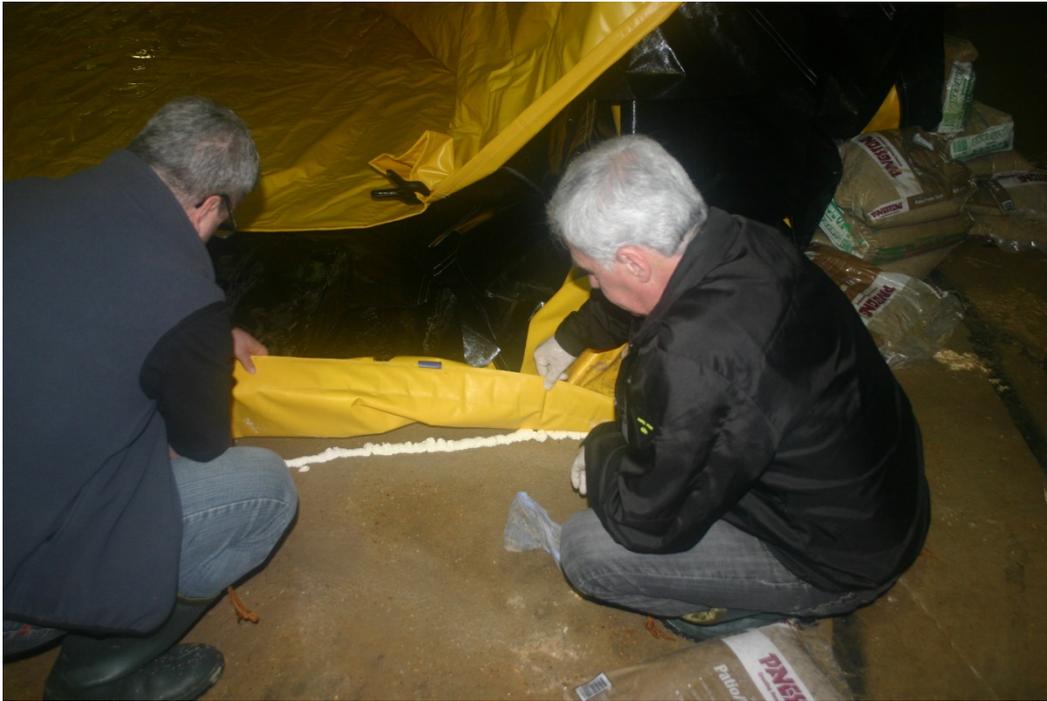
Figure 11. A strip of foam sealant is placed under the outer edge of the barrier to reduce seepage.

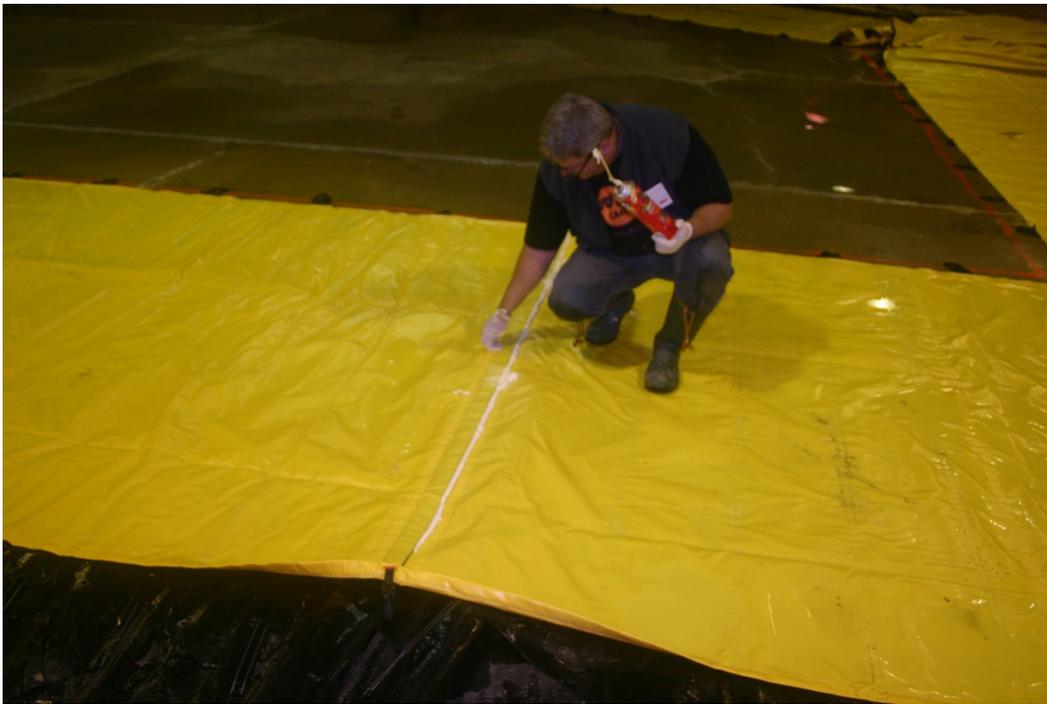
Figure 12. A strip of foam sealant is placed along the Velcro seam to reduce seepage.

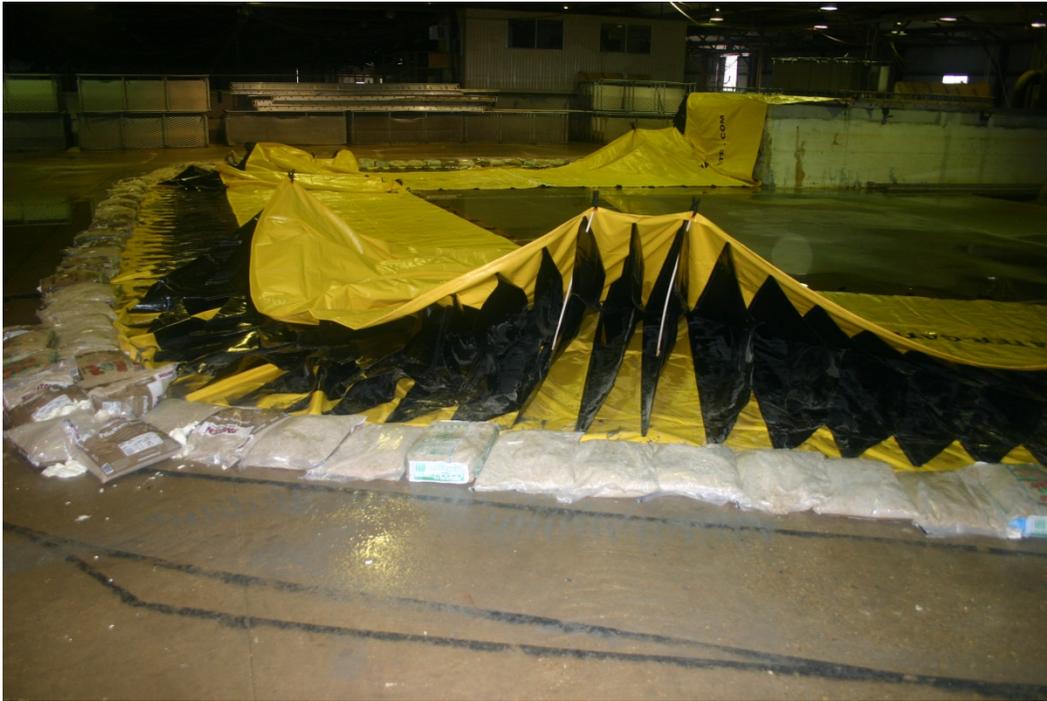
Figure 13. The completed installation with the addition of foam, sandbags, and dowels.

A row of sandbags was added to the outer edge of the barrier, with additional sandbags placed at the ends and at the corners. Finally, dowels were added to hold the barrier open at the ends and corners (Figure 13). The vertical panels in the barrier are made with a pair of holes in each panel, one near the top and one near the bottom, to hold the dowels.

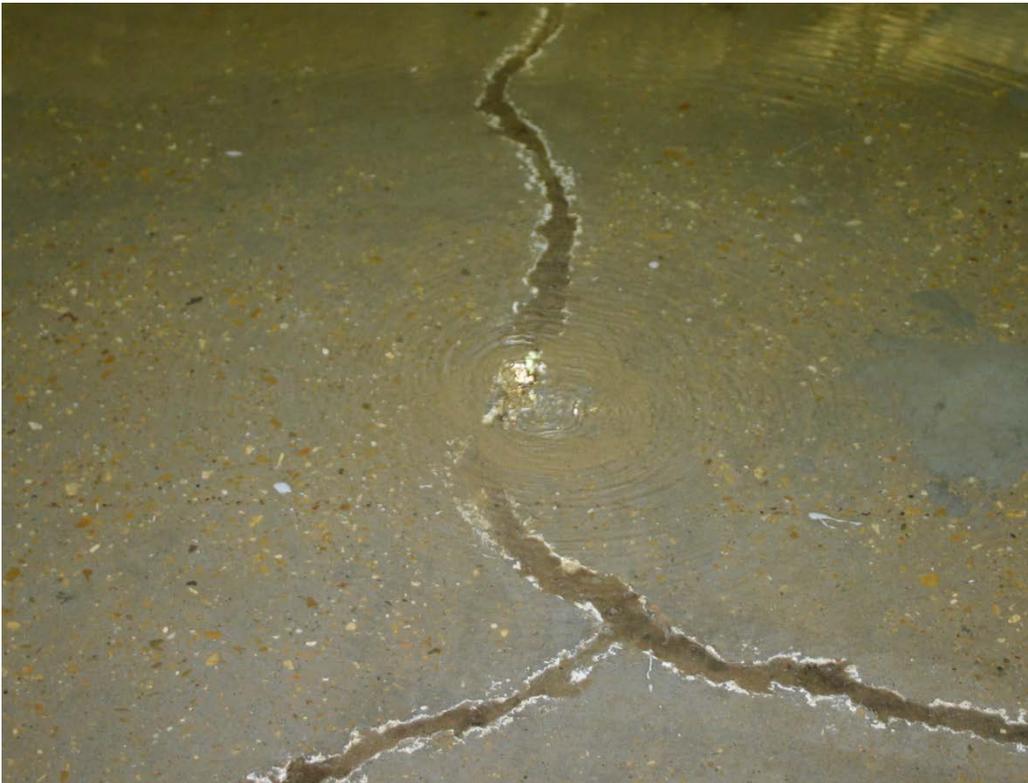
Figure 14. Seepage water coming up through a crack in the floor of the test area.

During recent tests with another product, seepage through cracks in the basin floor was observed in the test area (Figure 14). These cracks had been sealed but the cracks had apparently re-opened due to freeze/thaw cycles. An attempt was made to re-seal the cracks, but the attempt was not successful probably due to cold temperatures keeping the sealant from flowing into the cracks sufficiently to get a good seal. Therefore,

measurements were made of all significant leaks, then the total quantity was adjusted for additional minor leaks not measured. The result was a seepage rate through the floor that added 0.015 gallons per minute per foot of barrier length (gpm/ft) at a basin depth of 2 ft. Starting with zero seepage at zero depth, linear interpolation was used to estimate seepage rates at other depths. All seepage rates given in this report have the estimated floor seepage subtracted from the measured seepage.

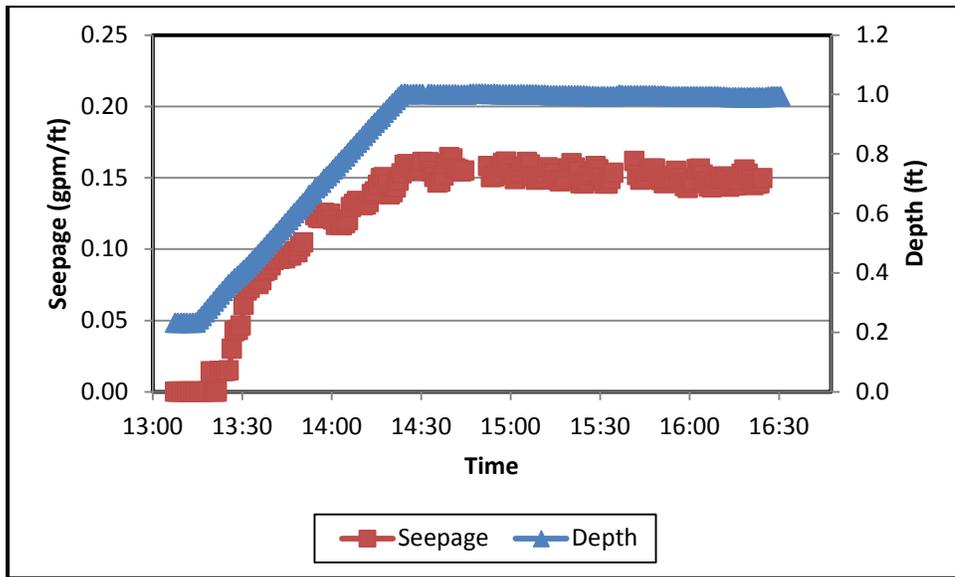
Figure 15. Seepage rates during filling and first two hours at one-ft depth.

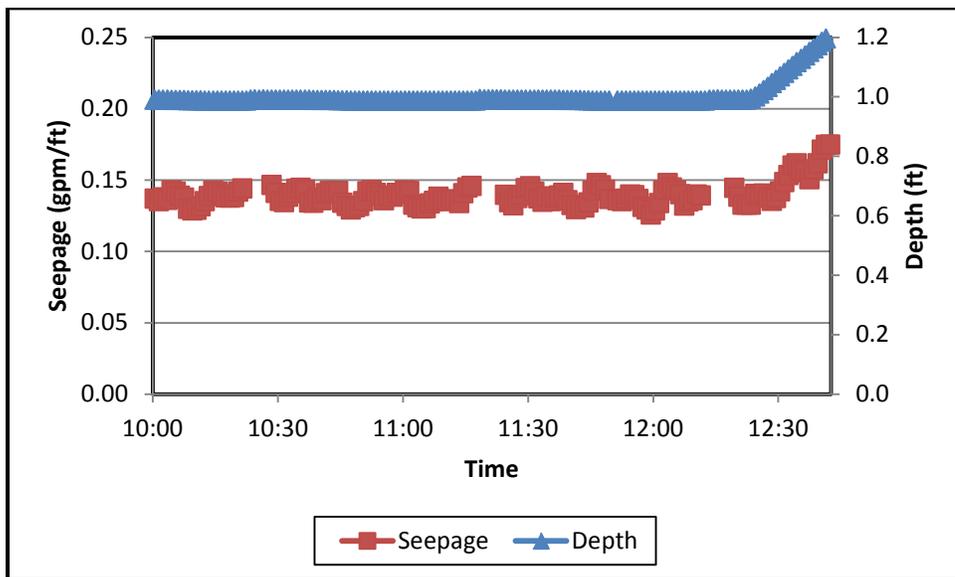
Figure 16. Seepage rates at end of 22-hr test.

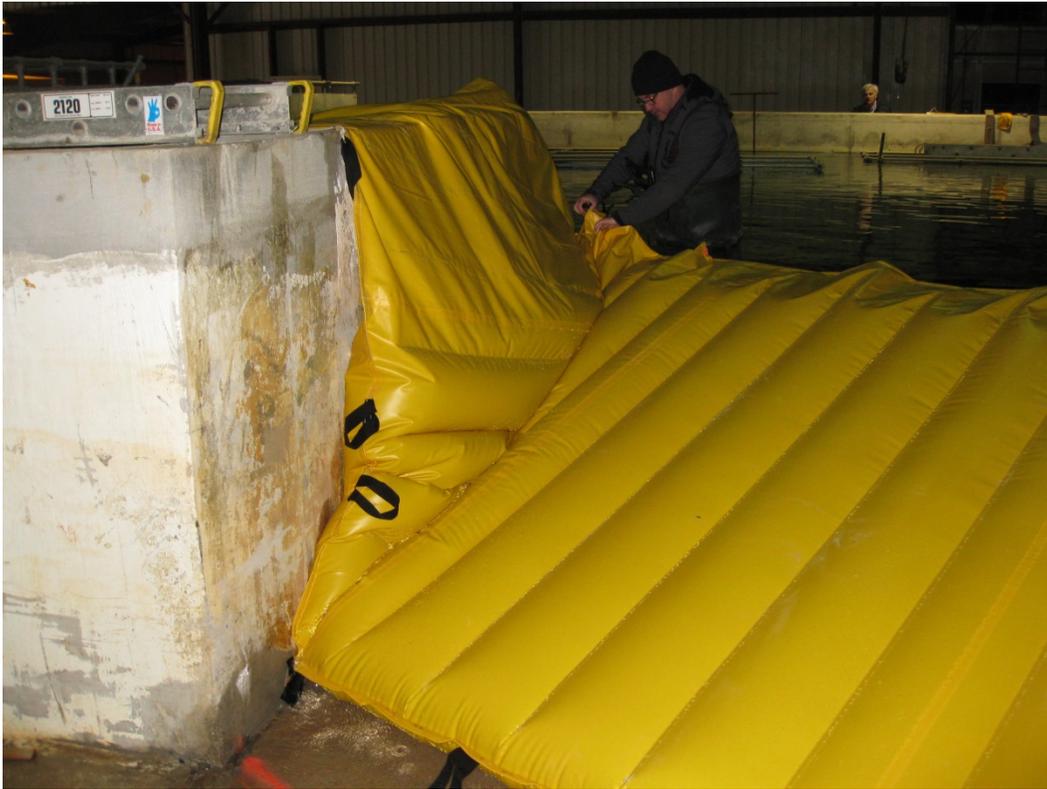
Figure 17. Raising the outer edge of the barrier to shut off a rivulet of overtopping near the wingwall.

For the most part, as the water level was rising the flotation in the top layer of the barrier was sufficient to keep the barrier above the water level. However, water did overtop the barrier in small localized areas and it was necessary to raise the outer edge of the barrier above the water to obtain the smallest possible seepage rates. This was especially true in the corners where the weight of the fabric in the folds hindered the rising of the upper edge of the barrier, or at the ends where the vertical sections going up the wingwalls prevented the top of the barrier from rising normally (Figure 17). This overtopping usually occurred only when the basin depth was being raised. Raising the outer edge was accomplished by a person in waders walking the perimeter.

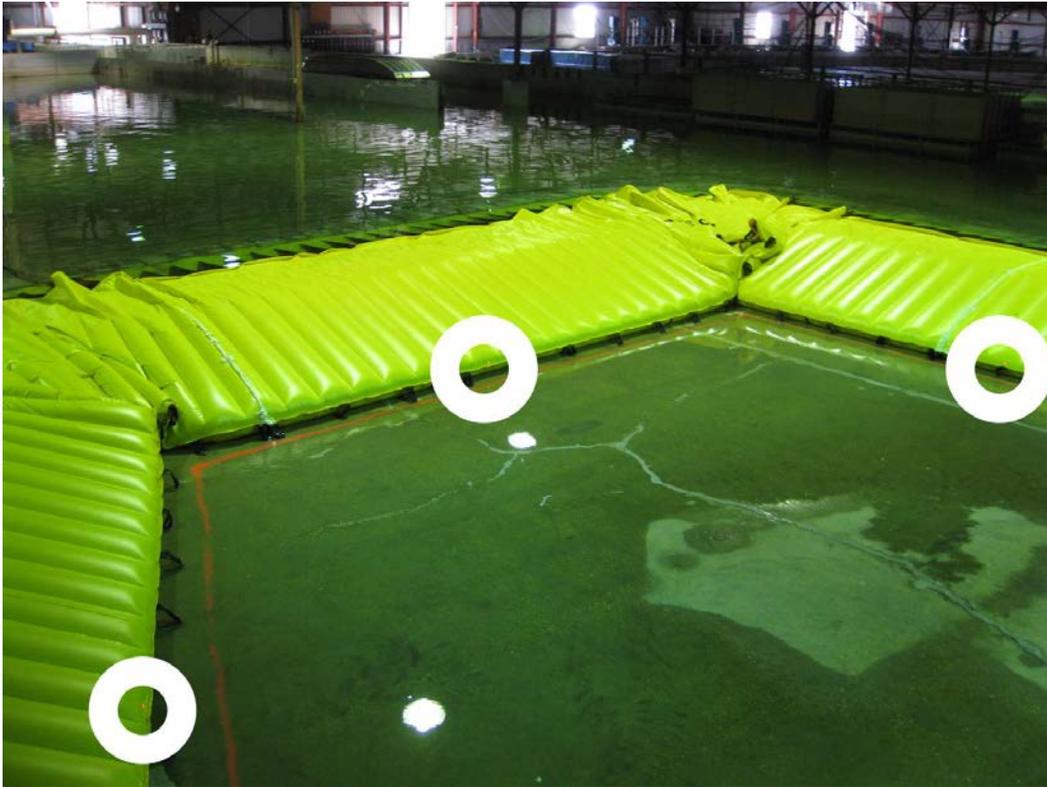
Figure 18. The red dot in the middle of each of the white "doughnuts" is the beam from the distance measuring laser.

The barrier was laid out in a modified “U” shape with a left wall, center wall, and right wall (when viewed from the test area looking out into the basin) (Figure 1). A distance-measuring laser was aimed at each of the three walls of the barrier at the approximate midpoint (horizontally) of the wall. Because the sloped back of the walls rose up and down with the water level, the lasers were aimed at the bases of the walls in an area that was nearly vertical and should stay in place (Figure 18). Any sliding of the barrier on the concrete was recorded by the lasers.

Movement of the barrier during filling to 2-ft depth is shown in Figure 24 and at the end of the 22-hr test in Figure 25. By the end of the test, the left wall had moved inward 0.014 ft, the center wall had moved inward 0.016 ft, and the right wall had moved inward 0.027 ft. For perspective, one-quarter inch is about 0.021 ft, so movement of each wall is on the order of one-quarter inch. There is no indication that any of the walls slid on the concrete floor of the basin. It is probable that as the upper surface of the barrier rose with the rising water it caused a minor shift in the areas where the distance-measuring lasers were pointing (Figure 18).

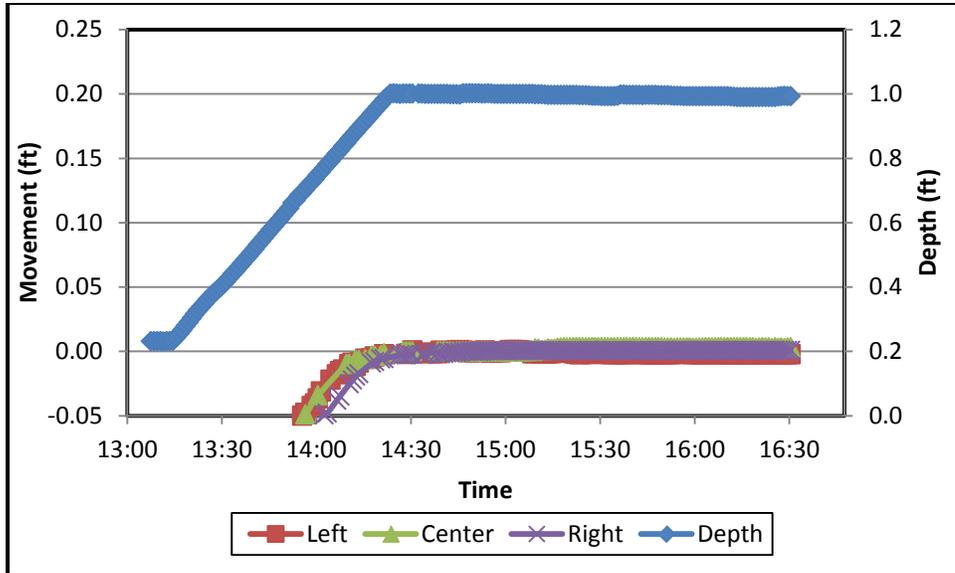
Figure 19. Movement of MegaSecur™ barrier during filling of basin to one-ft depth and first two hours at depth.

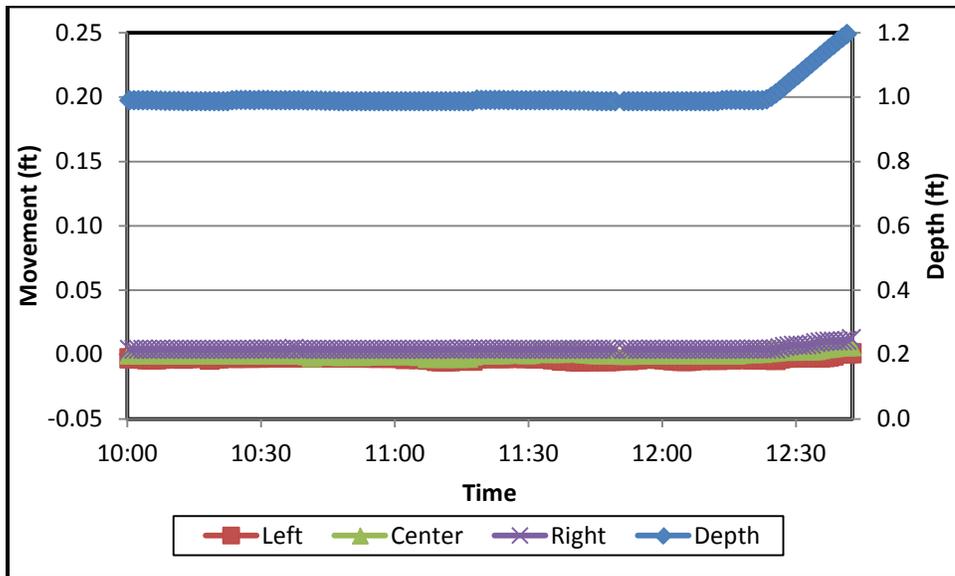
Figure 20. Movement of MegaSecur™ barrier at end of test at one foot water depth.

movement being 0.004 ft for the right wall by the end of the test (Figure 20).

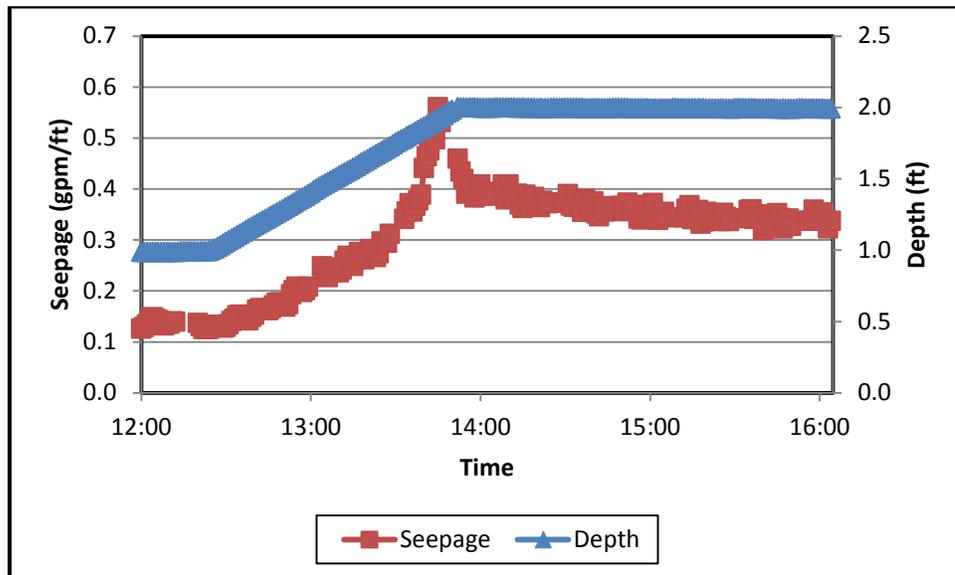
Figure 21. Seepage rate as depth in basin was increased from 1 ft to 2 ft.

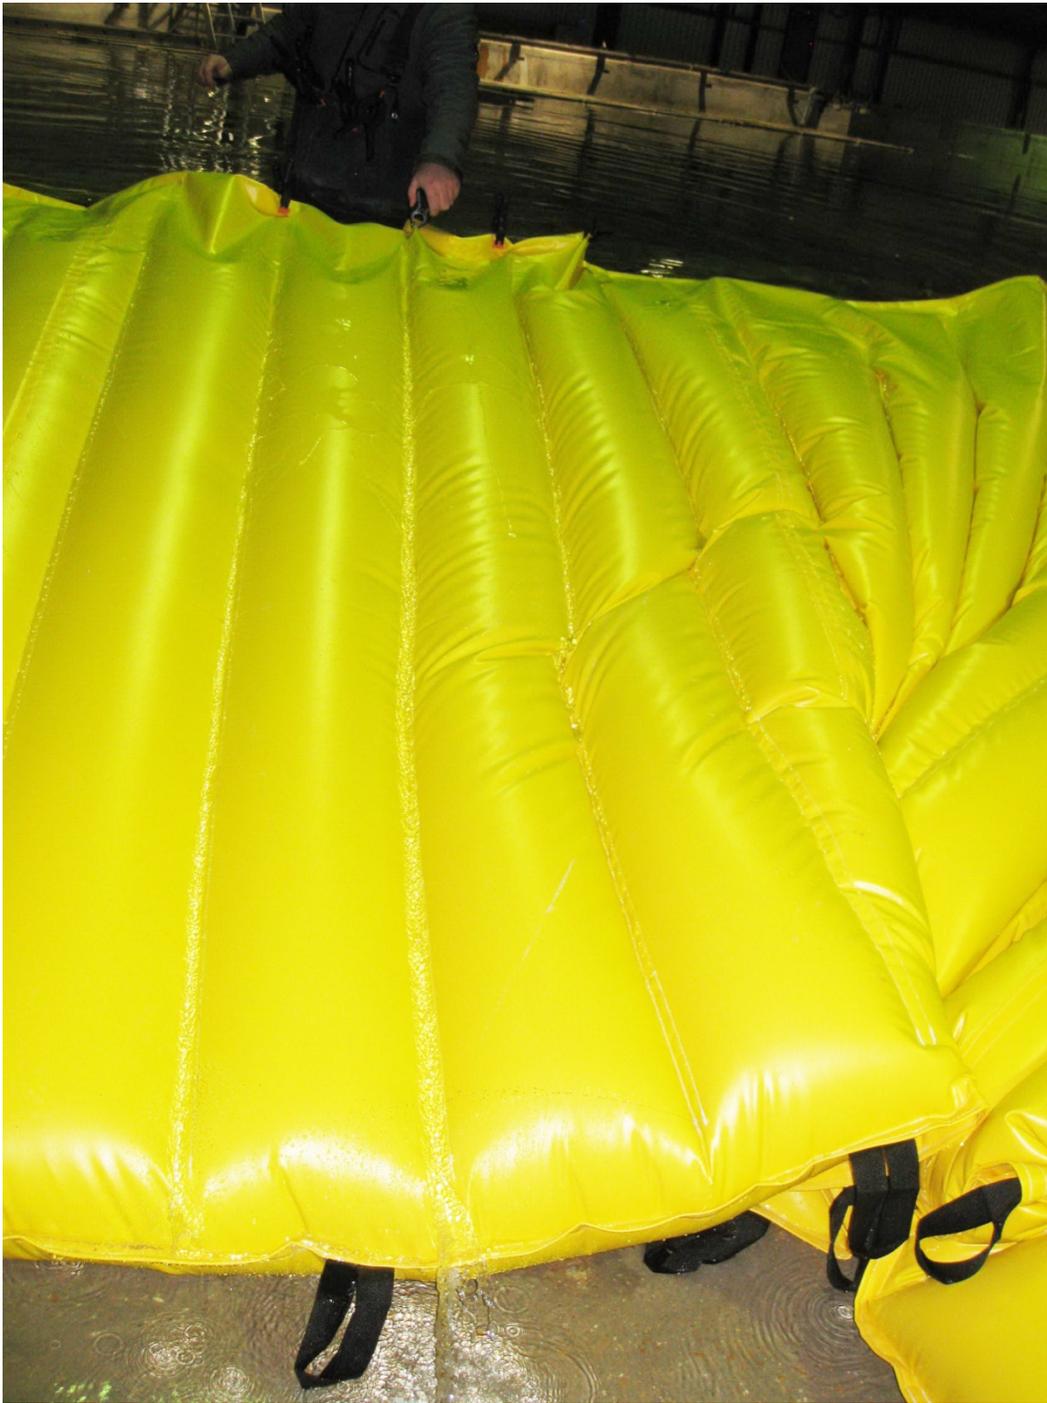
Figure 22. A clamp is placed to raise the outer edge and shut off the water flowing down the seam.

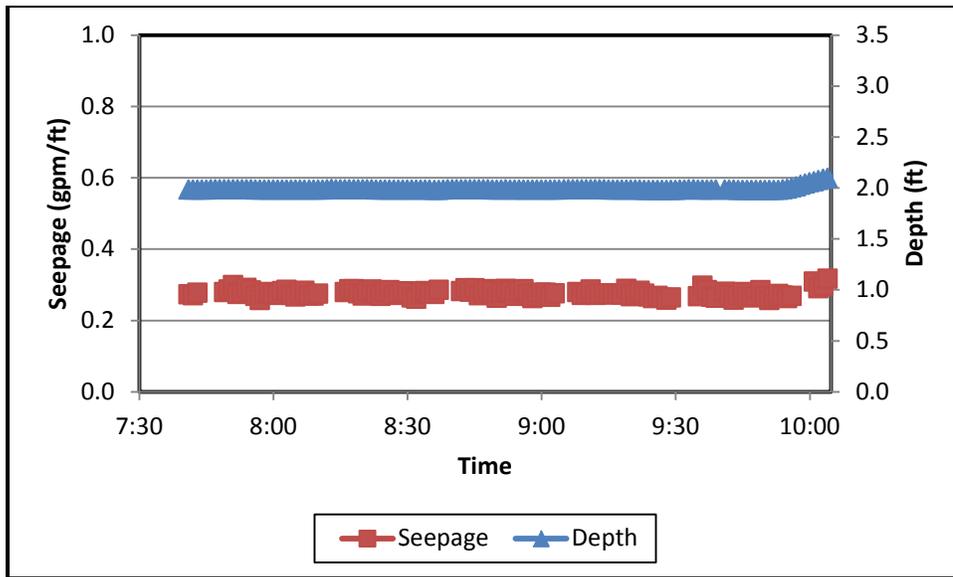
Figure 23. Seepage rate in basin during final 2 hrs of test at basin depth of 2 ft.

The next day ERDC was shut down as freezing rain produced hazardous driving conditions, but opened again the following day. That morning the seepage rate was down to 0.28 gpm/ft for the final two hours of the test (Figure 23).

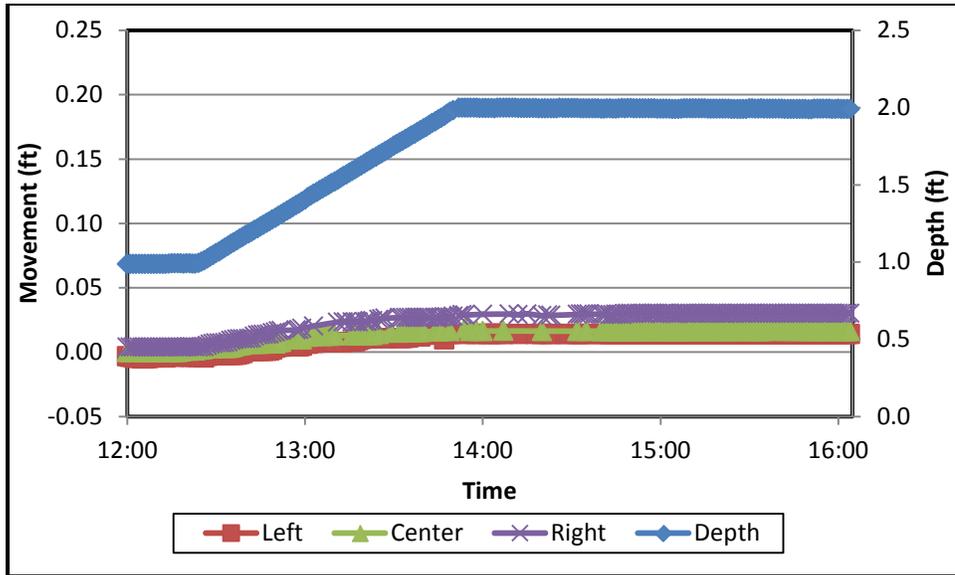
Figure 24. Movement of MegaSecur™ barrier during filling from basin depth of one ft to basin depth of two ft.

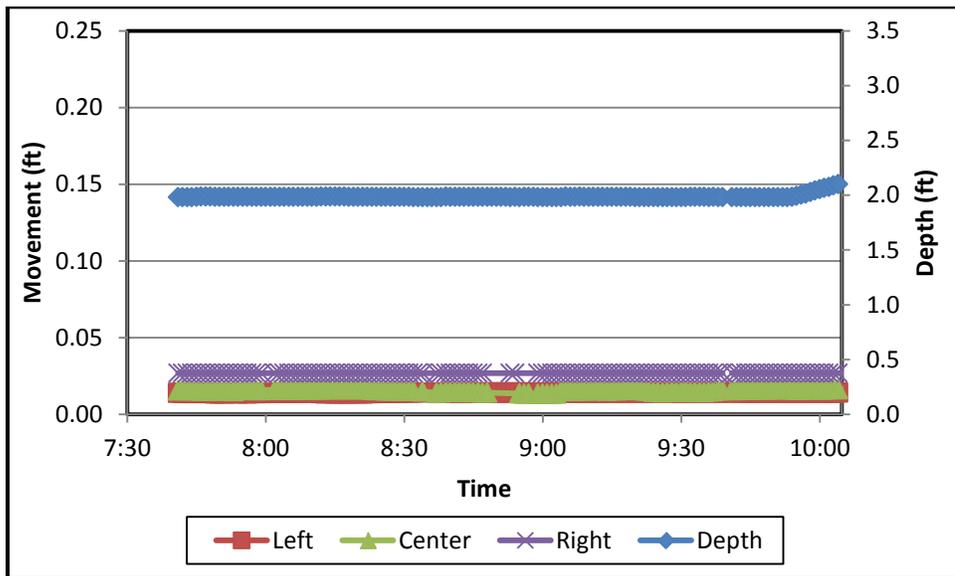
Figure 25. Movement of MegaSecur™ barrier at end of test at 2-ft basin depth.

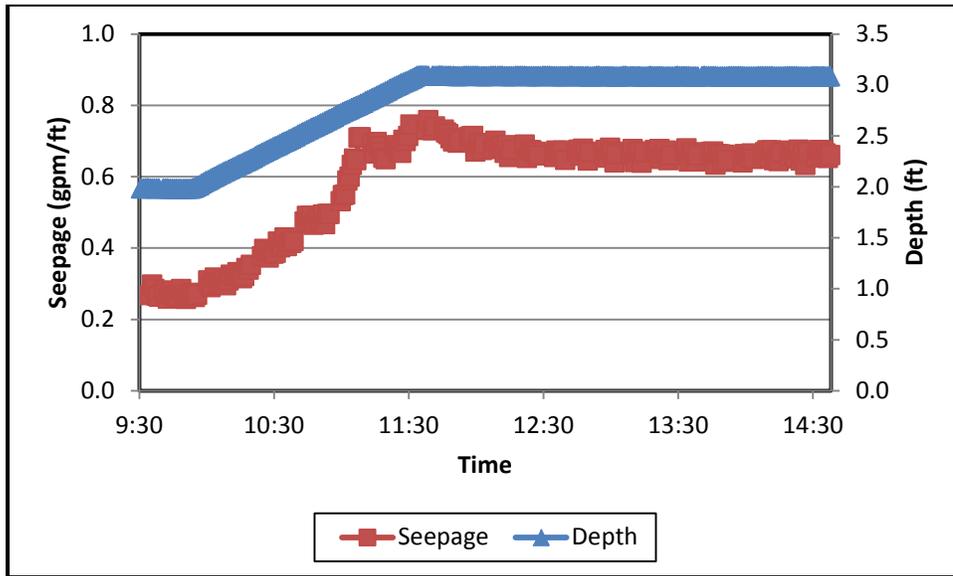
Figure 26. Seepage rates and depths as basin water level is raised to 95% of structure design depth.

As the water level in the basin rose, there was some overtopping particularly at the ends and corners of the barrier. Seepage rate rose as high as 0.75 gpm/ft before the addition of more clamps to the outer edge of the barrier stopped the overtopping. Seepage rate then came back down to an average of 0.66 gpm/ft between 13:30 and 14:30 (Figure 26), and down to 0.60 the following morning (Figure 27).

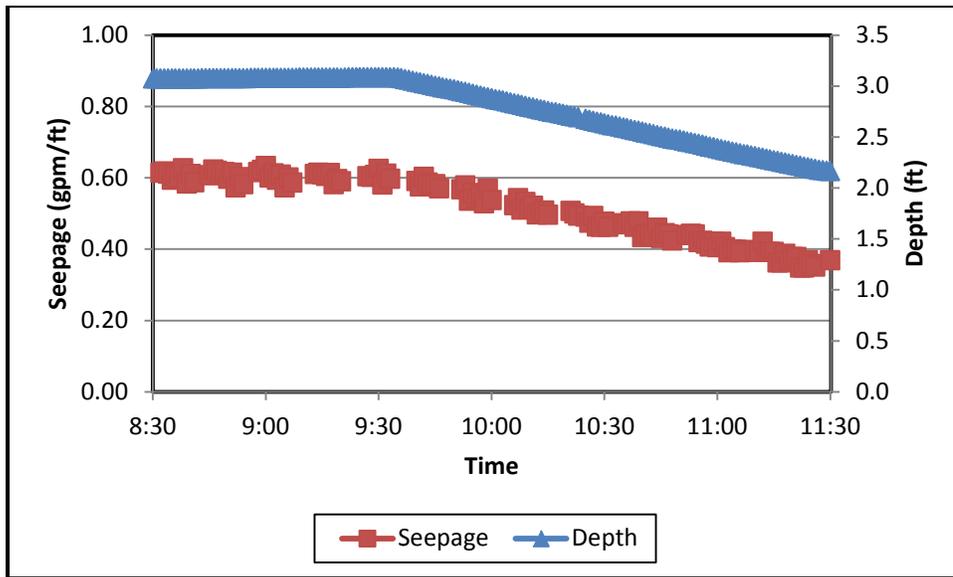
Figure 27. Seepage and water depths during end of 95% depth test and lowering water for small waves test at low water.
