**US Army Corps
of Engineers®**
Engineer Research and
Development Center

Evaluation of MegaSecur™ Flood Protection Barrier

Donald L. Ward

April 2015

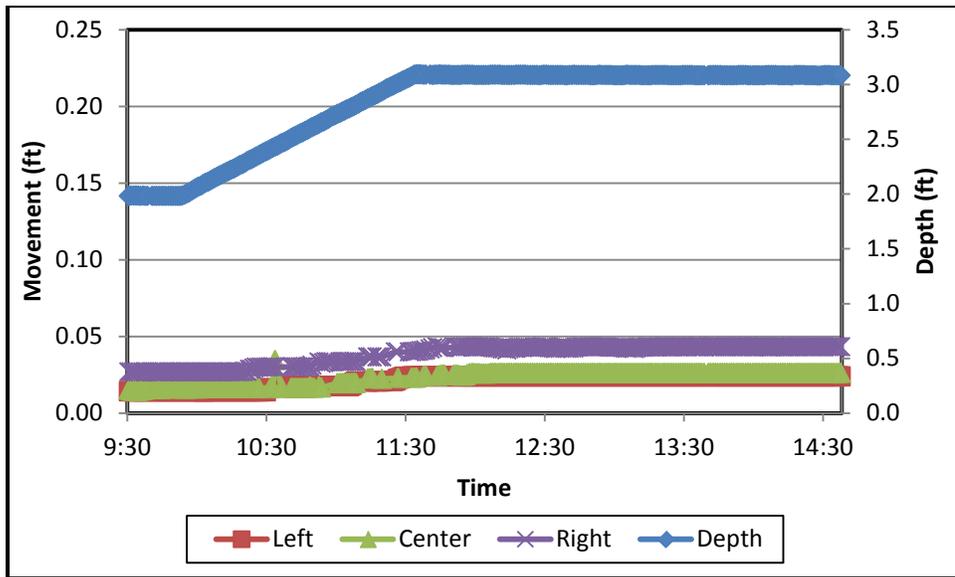
Figure 28. Movement of barrier during raising of basin water level to 95% structure design depth and first hours of test.

Movements of the barrier during raising the water level to 95% structure design depth and during the first hours of the test are shown in Figure 28 and during the final hour of the test in Figure 29. By the end of the test, the left wall had moved inward 0.024 ft, the center wall had moved inward 0.025 ft, and the right wall had moved inward 0.043 ft. Again, there was no indication of sliding or any movement other than adjustments in the wall due to the lifting of the upper fabric by the rising water. However, when the water level was brought back down at the end of the test, the measurements did not change (Figure 29).

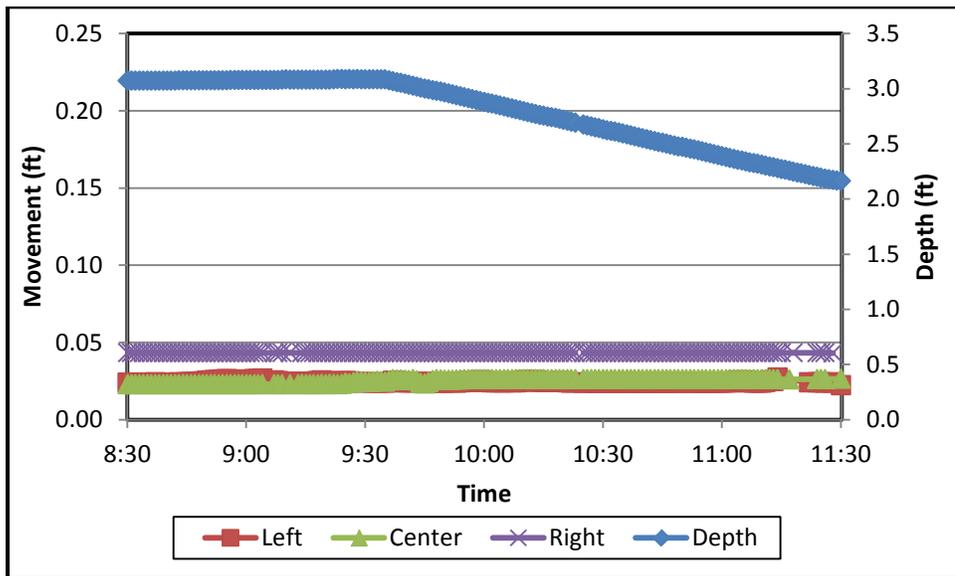
Figure 29. Movement of barrier during end of test at 95% depth and lowering water for small waves test at low water level.

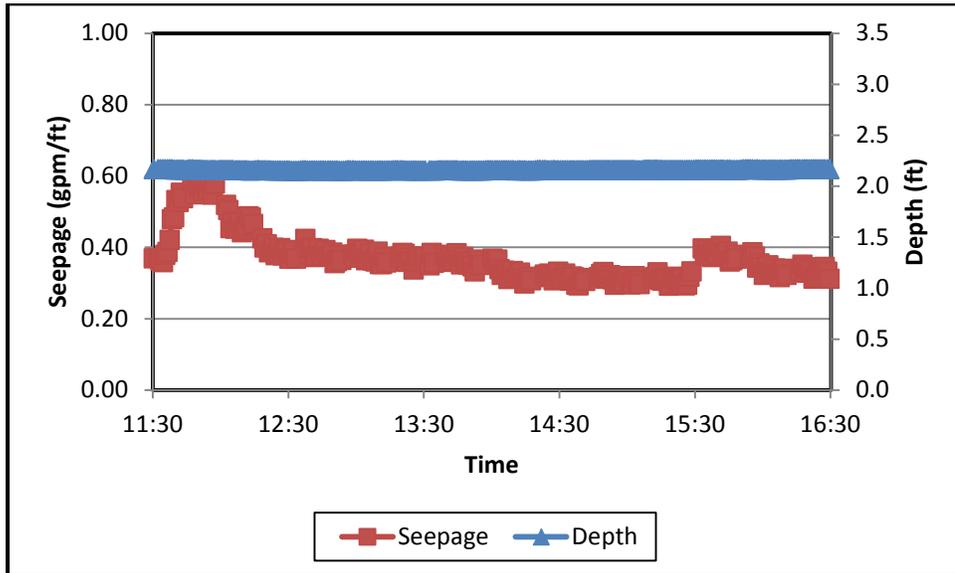
Figure 30. Seepage rate during small waves test at basin depth of 2.18 ft.

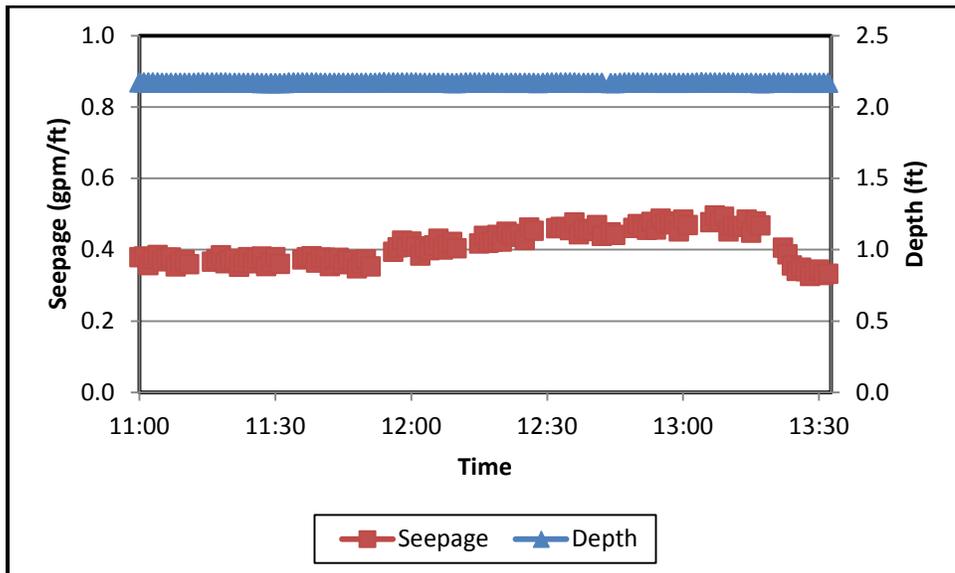
Figure 31. Second day continuation of small waves test at low water.

the seepage rate gradually rose to 0.48 gpm/ft, then dropped again after the waves were stopped to 0.33 gpm/ft (Figure 31)

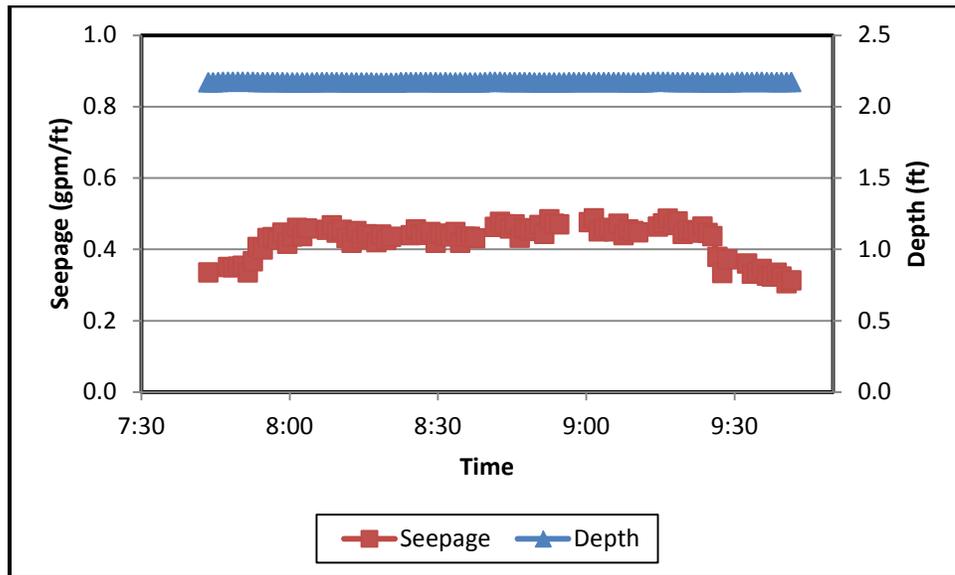
Figure 32. Third day completion of small waves test at low water.

The following day the final 1 hr 39 min of the test was completed with the waves started at 7:52. Before starting the waves the seepage rate was 0.35 gpm/ft, averaged 0.45 during the waves, then dropped again at the end of the test.

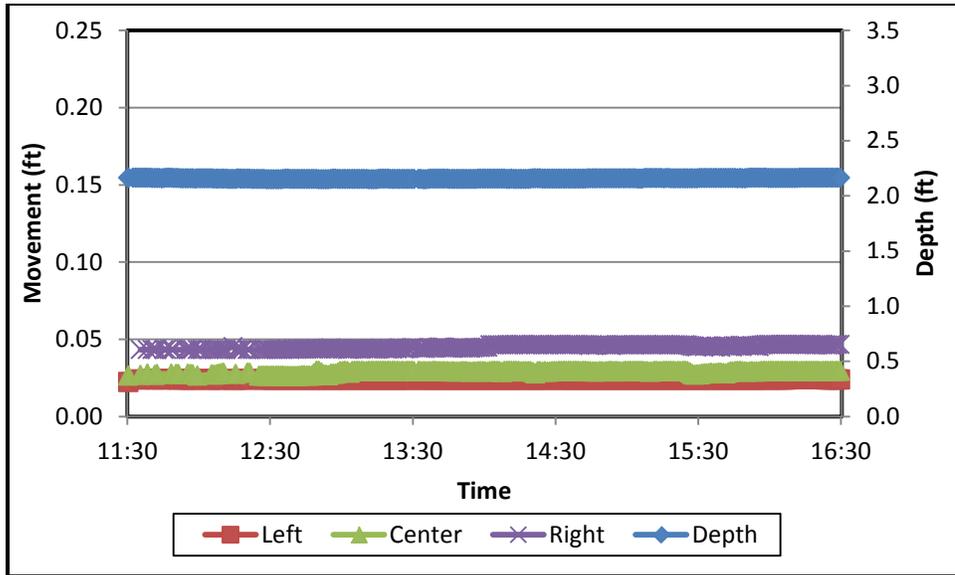
Figure 33. Movement of barriers during small waves test at basin depth of 2.18 ft.

Movement of the barrier is shown during the first day of testing in Figure 33, second day of testing in Figure 34, and third day of testing in Figure 35. There was no significant movement. Between the beginning of the test and the end of the test the left wall did not move, the center wall moved inward 0.001 ft, and the right wall moved inward 0.003 ft.

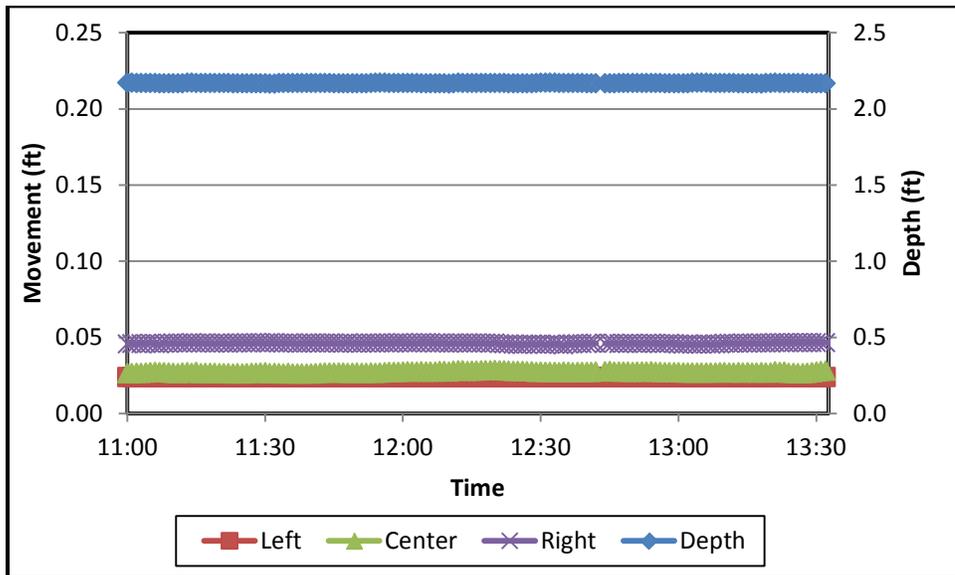
Figure 34. Second day continuation of small waves test at low water.

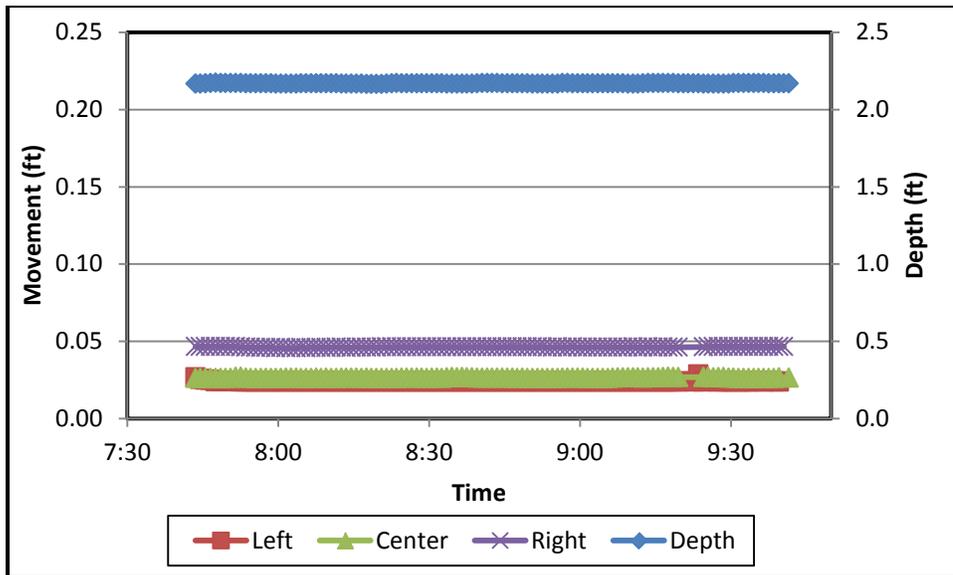
Figure 35. Third day completion of small waves at low water.

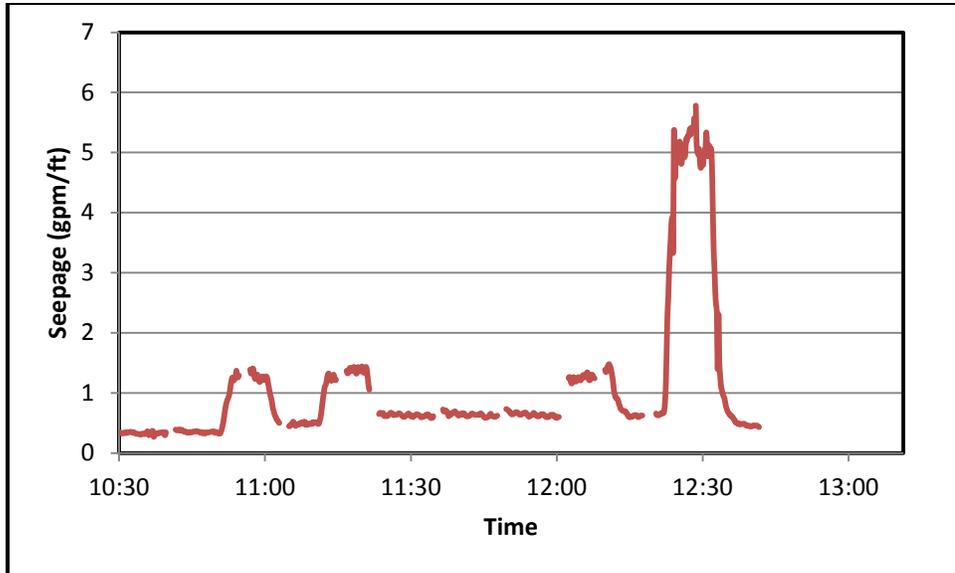
Figure 36. Seepage rates during tests with 6- to 8-in. wave heights and 10- to 12-in. wave heights with basin depth at 2.18 ft.

Some overtopping was observed in each of the three runs in the corners at the ends of the center wall, and to a lesser extent along the center wall. Water passing beneath the barrier was seen to “pulse” with the wave action. Average seepage plus overtopping for each of the three runs was 1.12, 1.24 and 1.26 gpm/ft respectively (Figure 36).

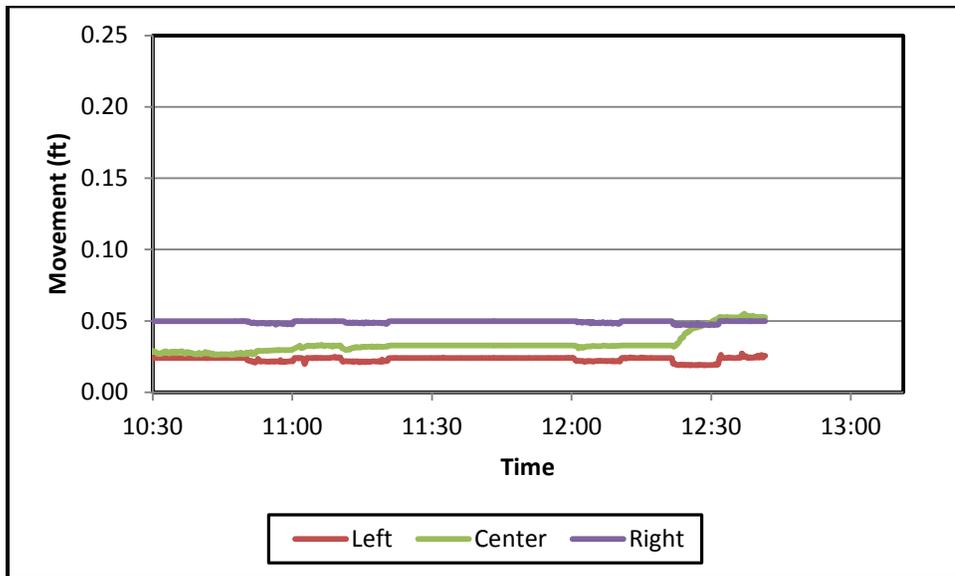
Figure 37. Movement of barriers during tests with medium and large waves at 2.18 ft depth.

three runs. That is a total movement of about one-sixteenth in. (Figure 37).

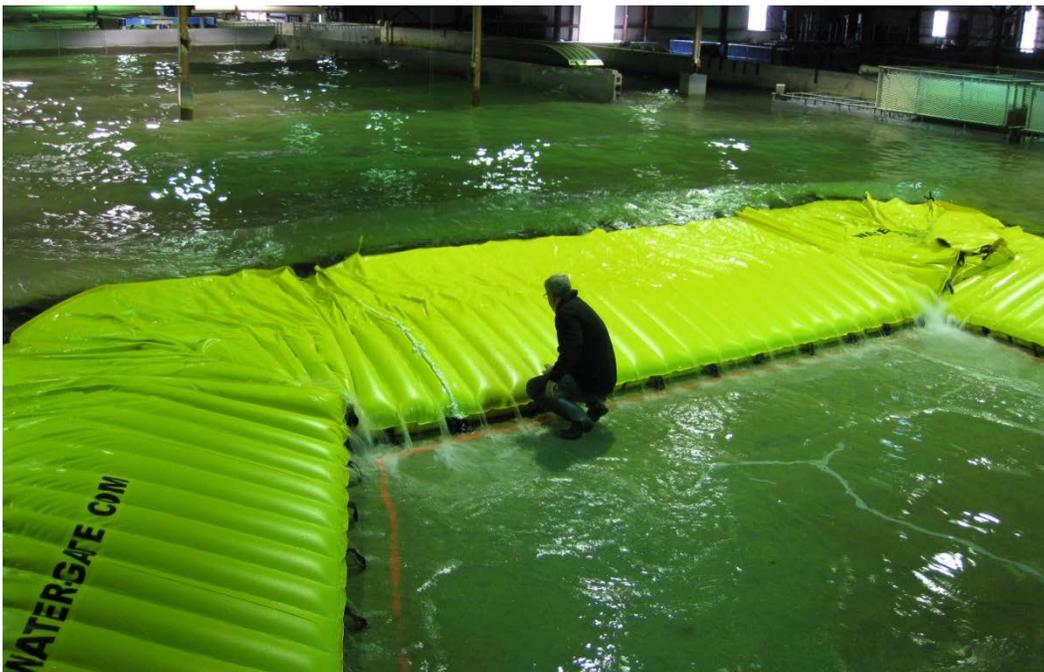
Figure 38. Barrier during test with large waves at low water.

The barrier is shown in Figure 38 during the test with large waves at the low water level.

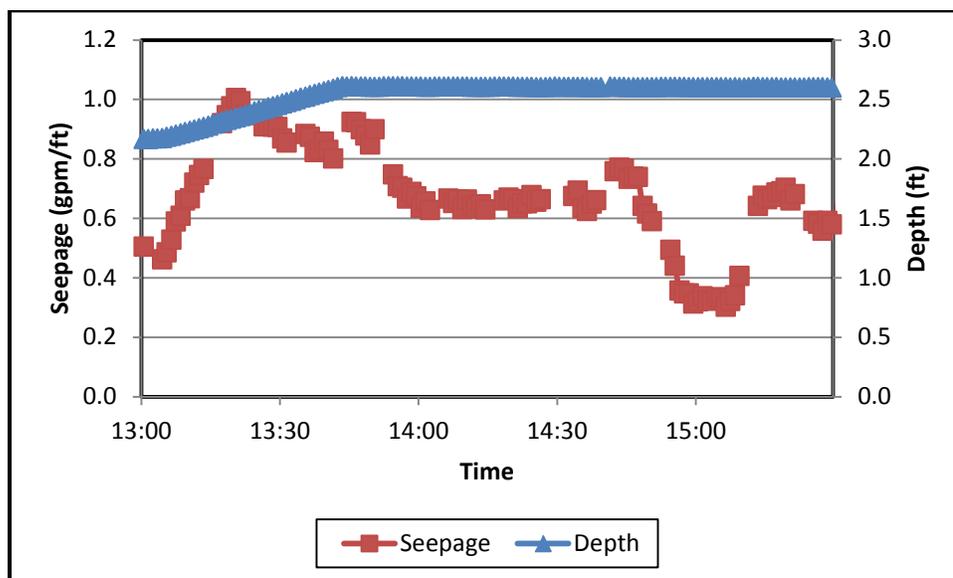
Figure 39. Seepage rates during the high water tests with small waves.

The basin water level was raised to 80% of the structure design depth, or 2.60 ft, for the high water wave tests. Monochromatic waves with a period of 2 sec and wave height of about 2 in. were run for a period of one hour. There was no damage to the structure noted. Instead of running the small waves test for the full 7 hrs, the testing engineer has the option of stopping the small waves test at high water at any time after a minimum of 1 hr. Because no damage to the structure was observed and there was no indication that continuing to run the small waves would have any effect on the structure, the test was stopped after one hour. In Figure 39 (seepage) and Figure 40 (movement), the small waves were started at 13:50.

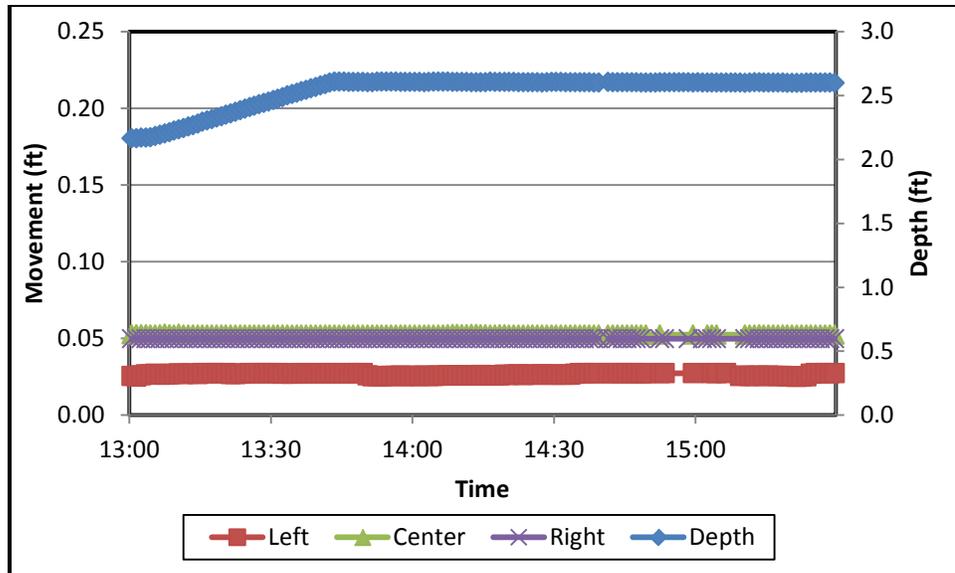
Figure 40. Movement of barriers during the high water waves tests with small waves.

Movement of the barrier was minimal, with no wall moving more than 0.001 ft (Figure 40).

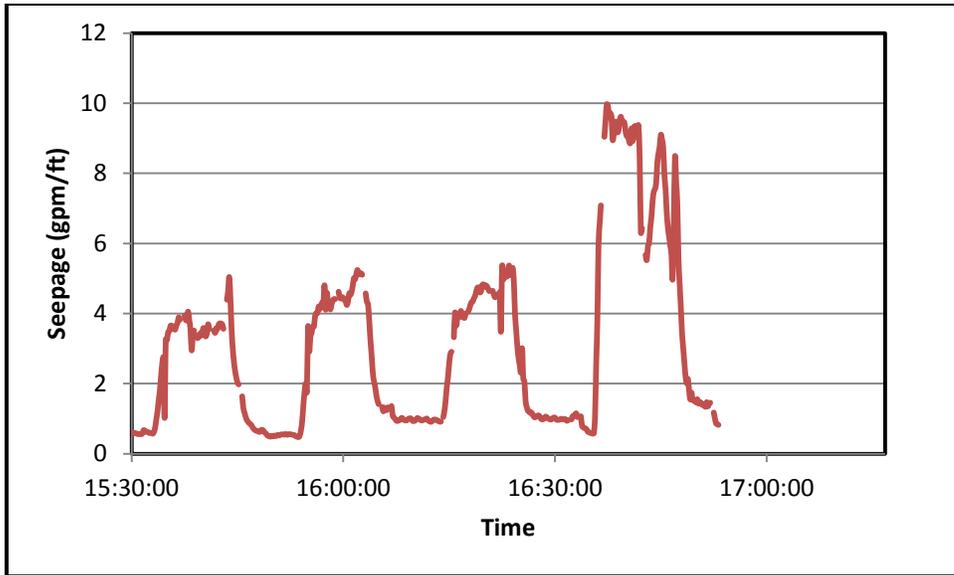
Figure 41. Seepage plus overtopping rates for tests with medium and large waves at high water.

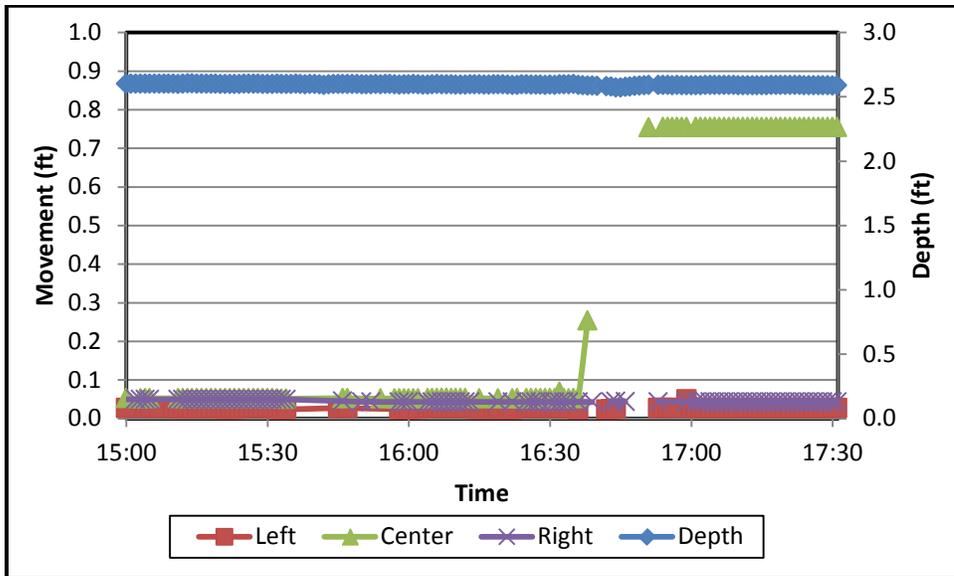
Figure 42. Movement of barrier during tests with medium and large waves at high water.

Prior to the three runs, the barrier walls were inward 0.027 ft, 0.52 ft, and 0.50 ft for the left, center, and right walls, respectively. At the end of the three runs, the left and center walls had not moved but the right wall was at 0.043 ft inward from the initial values (Figure 42).

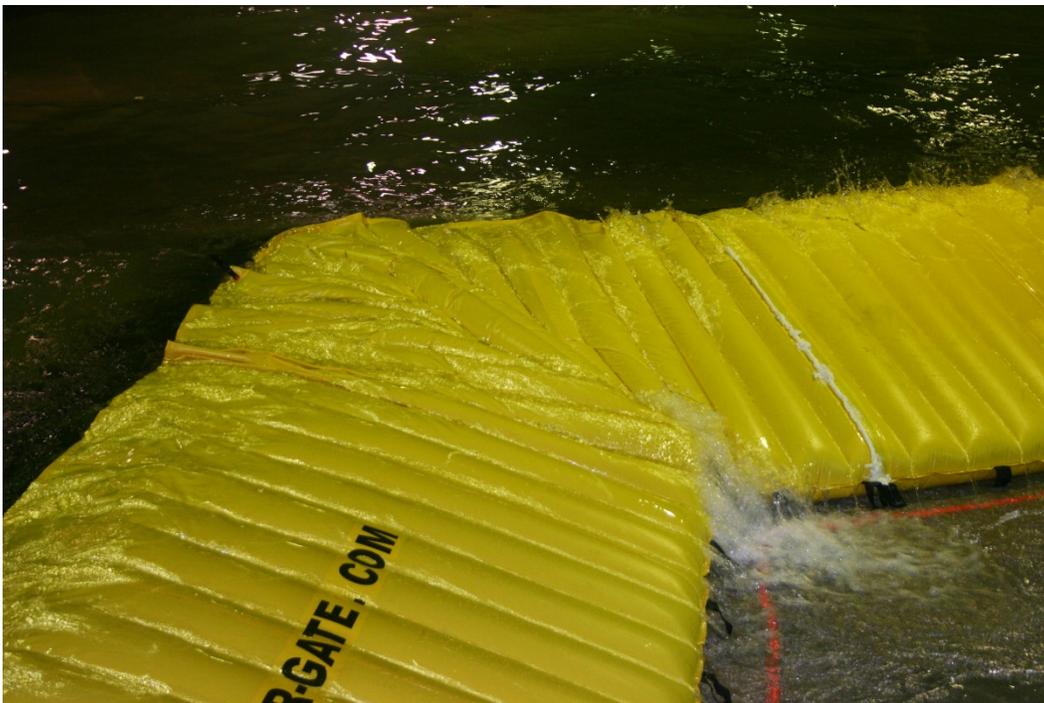
Figure 43. Barrier being overtopped during test with large waves at high water.

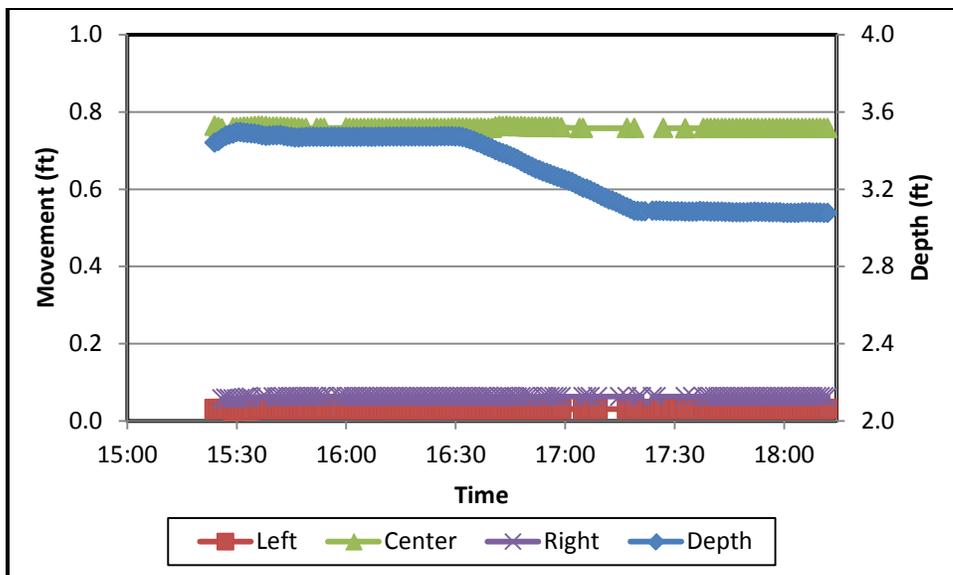
Figure 44. Movement of the barrier during the overtopping test and the final static water test.

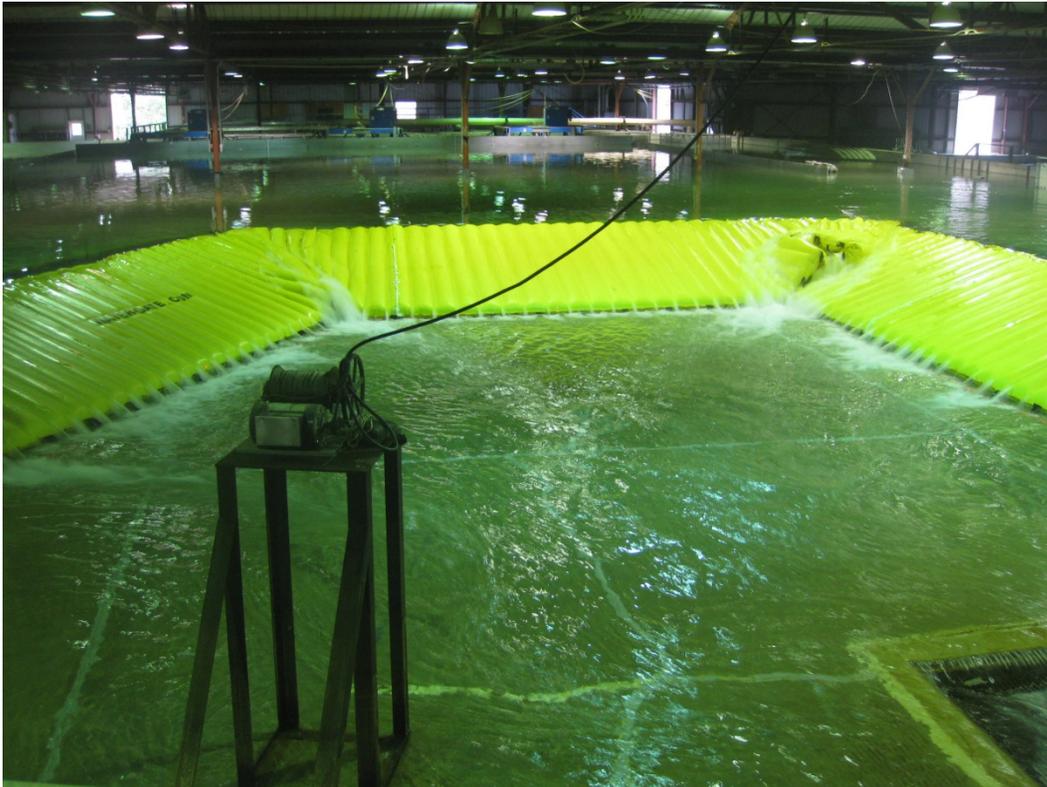
Figure 45. Overtopping of the barrier.

The barrier is shown in Figure 45 during the overtopping test. There was no apparent damage to the barrier.

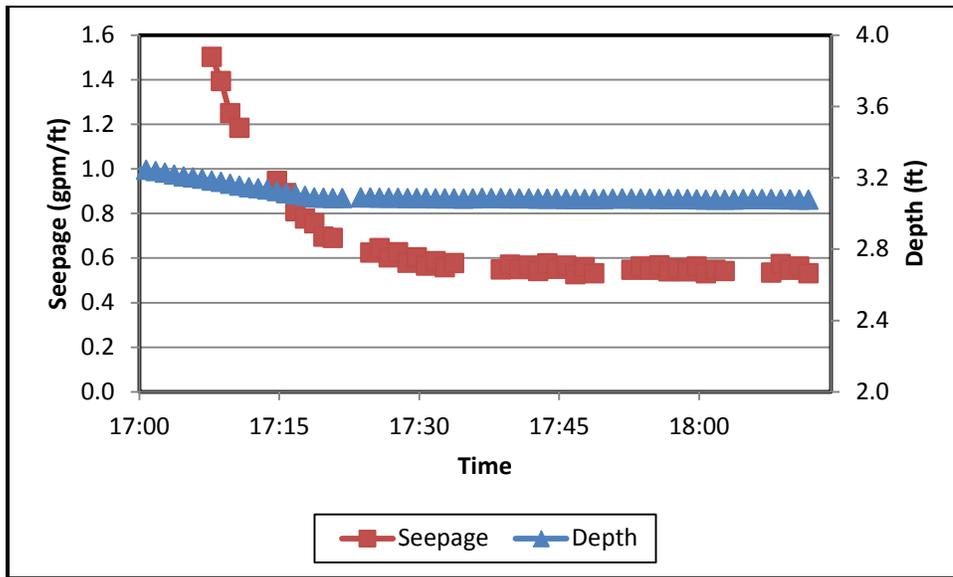
Figure 46. Seepage rates as water is brought down to 95% depth from the overtopping test, then maintained for the final static seepage test.

Figure 46 shows the water level coming down from the overtopping test then maintained at 95% of design height (3.1 ft) for the static seepage test. For the period from 17:17 to 18:17, the average seepage rate was 0.55 gpm/ft. In the initial test at 95% structure design depth, the seepage rate was 0.60 gpm/ft.

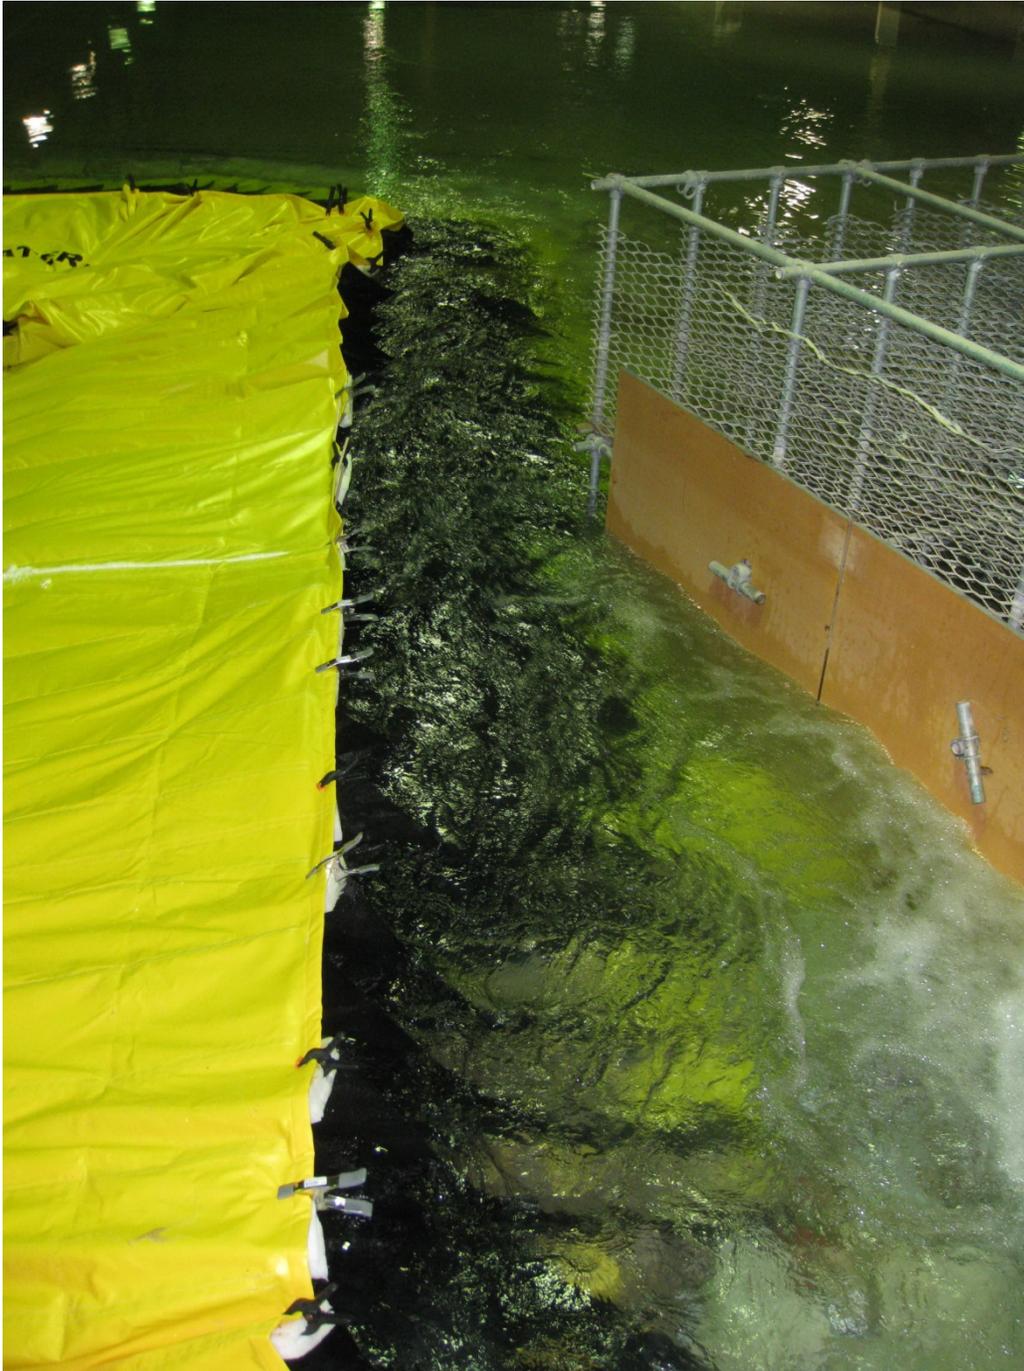
Figure 47. Barrier during the current test. Pieces of Styrofoam are seen clamped to the upper layer for flotation.

Lateral forces on the vertical panels caused by a large current flowing along the barrier were able to pull down the upper layer of the barrier and cause the barrier to be overtopped. Clamping pieces of Styrofoam to the upper layer of the barrier provided sufficient additional flotation to prevent the overtopping.

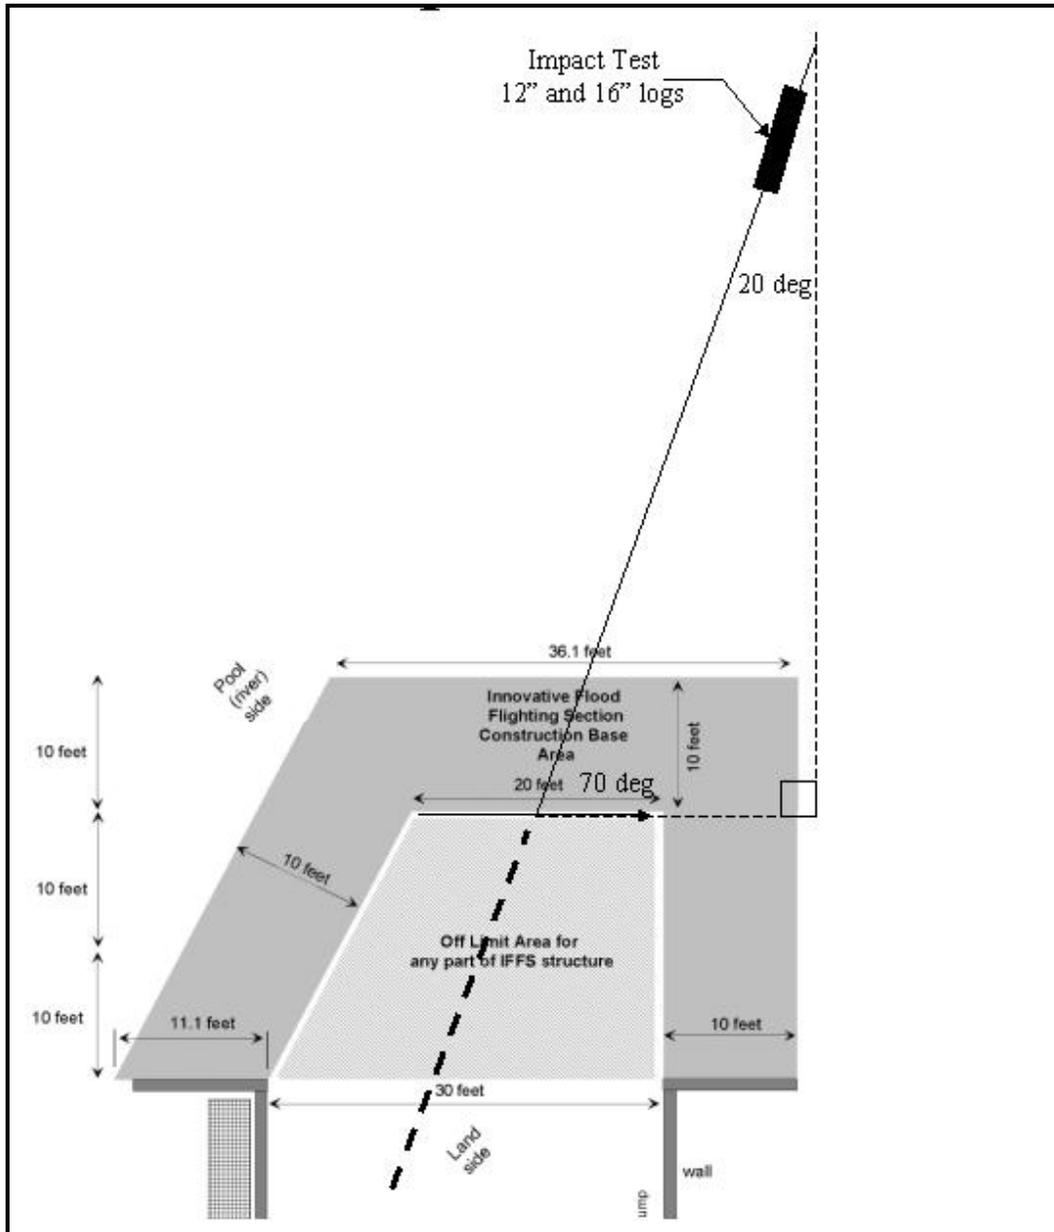
Figure 48. Setup for debris impact tests.

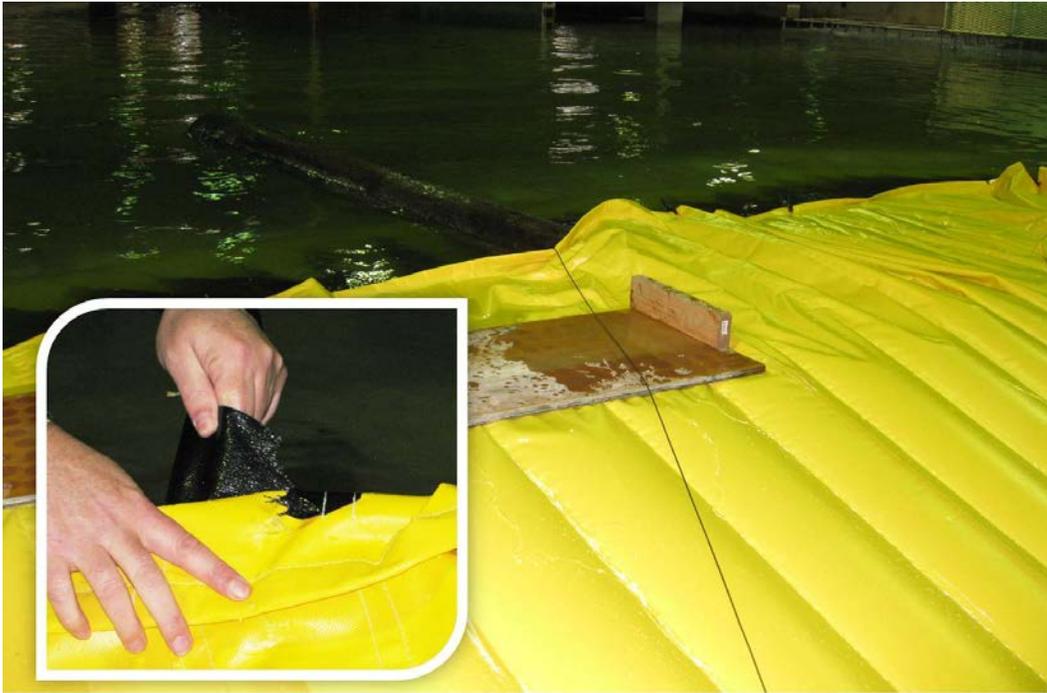
Figure 49. Barrier after being struck by small log. Insert shows tear in vertical panel.

The two logs were towed into the structure one at a time, the smaller log first. The test with the smaller log is shown in Figure 49. The piece of plywood on top of the barrier was to protect the fabric from the cable. The log struck directly on one of the vertical panels inside the barrier, causing a small tear in one panel (Figure 49, insert). No other damage was found.

One of the logs in the debris impact test hit directly on one of the vertical panels, causing a small tear in the fabric. Other than that, there was no damage to the MegaSecur™ units.

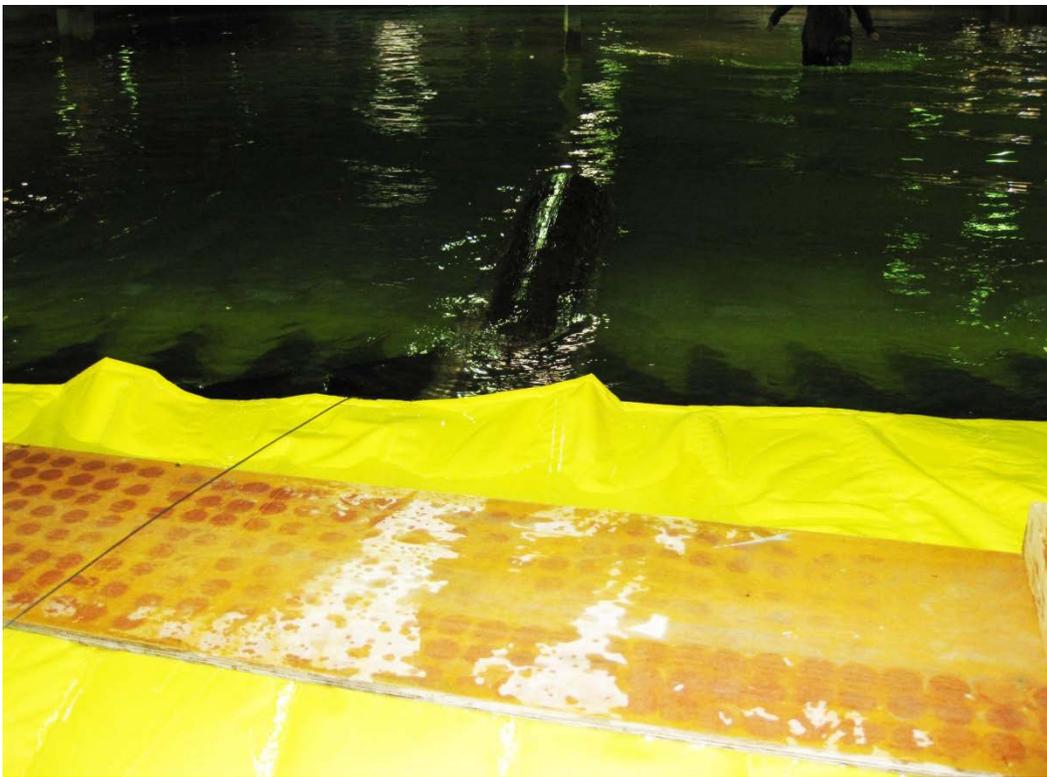
Figure 50. Barrier after being struck by large log. No damage was found on the barrier.

The large log is shown in Figure 50 after impact. The log hit between the vertical panels and caused no visible damage.

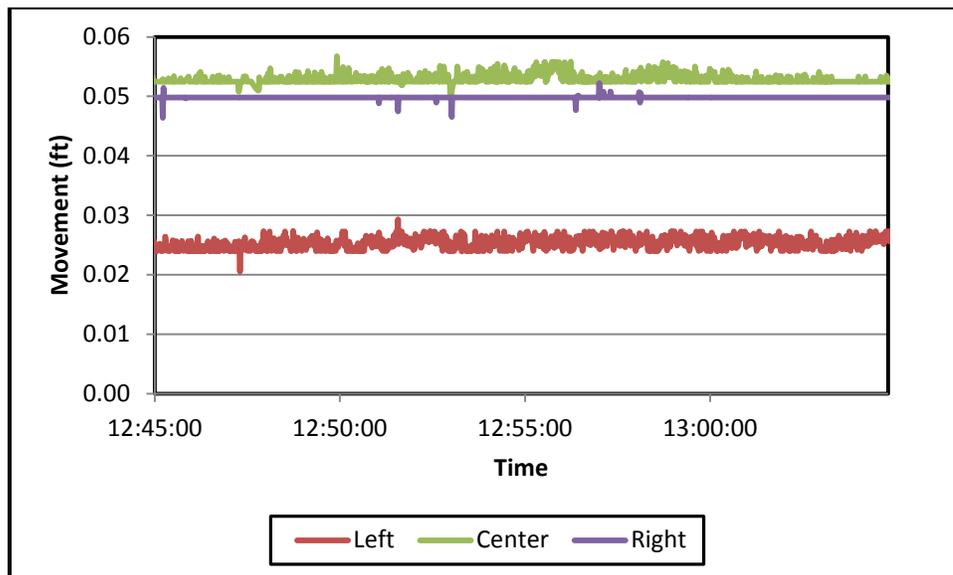
Figure 51. Movement of the barrier during the debris impact tests.

Movement of the barrier during the debris impact tests is shown in Figure 51. The figure shows 1-sec averages of the distance-measuring lasers. The figure has been filtered to remove large apparent motion caused by people walking between the laser and the barrier. The resolution of the lasers is 1 mm, or about 0.003 ft. The lasers were recording at about 20 Hz, so each data point is the average of about 20 readings. The small log impact occurred around 12:47 and the large log at 12:53. Examination of the raw data file showed no movements greater than 1 mm from either impact.

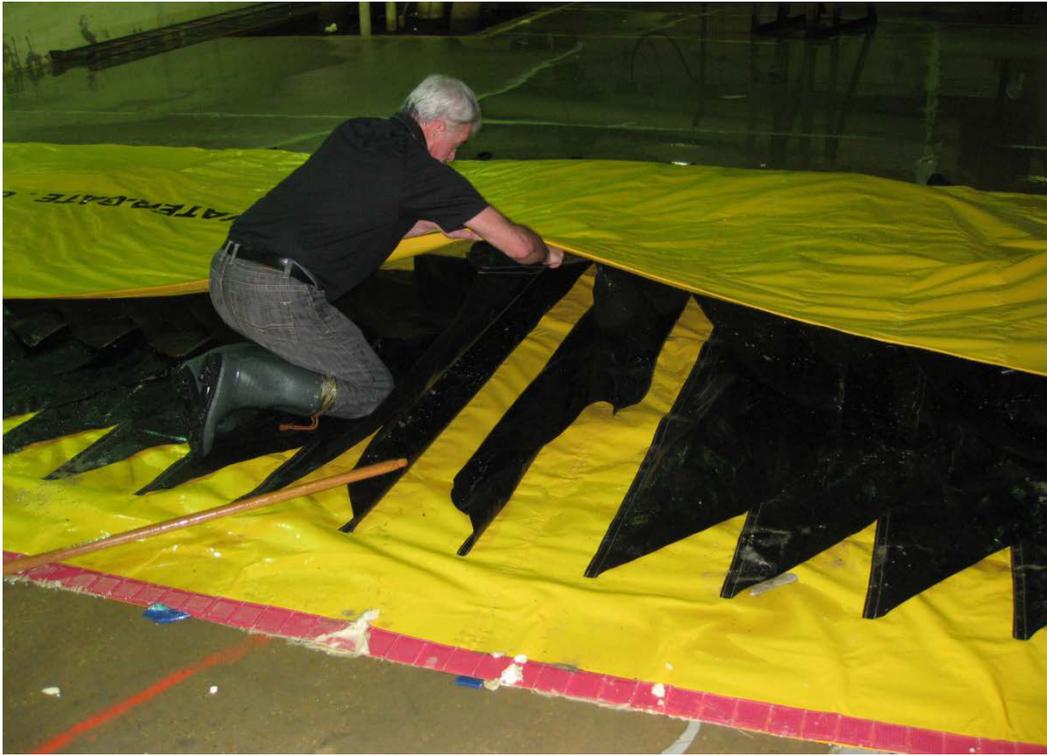
Figure 52. A tug on the seam of each of the vertical panels allowed the panels to lay flat.

Disassembly consisted of detaching the Velcro seams holding the three sections of barrier together and laying each section out straight. Then a quick tug on the seam of each of the vertical panels was sufficient to get the panels to lay flat (Figure 52). The barrier was folded lengthwise in quarters (Figure 53), rolled up (Figure 54), and packed into a carry bag. Two people completed the disassembly and packing in 60 minutes, plus one person driving a Bobcat™ skid-steer loader for 18 minutes to remove the sandbags. Complete removal of the barrier took 2.3 man-hrs.

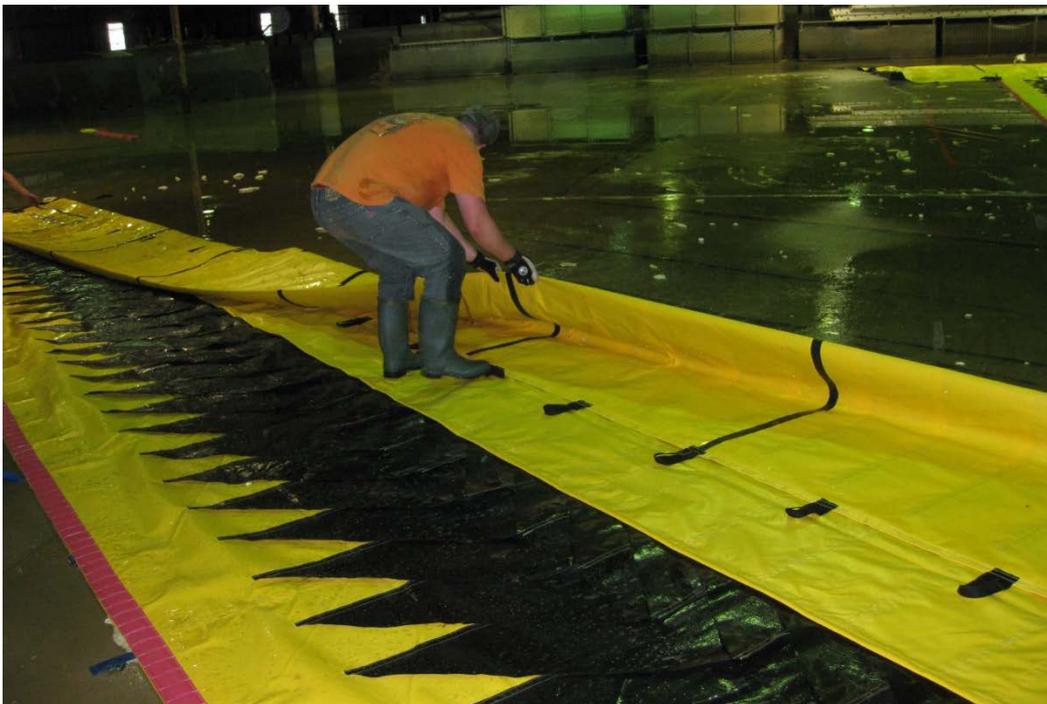
Figure 53. The barrier is folded lengthwise.

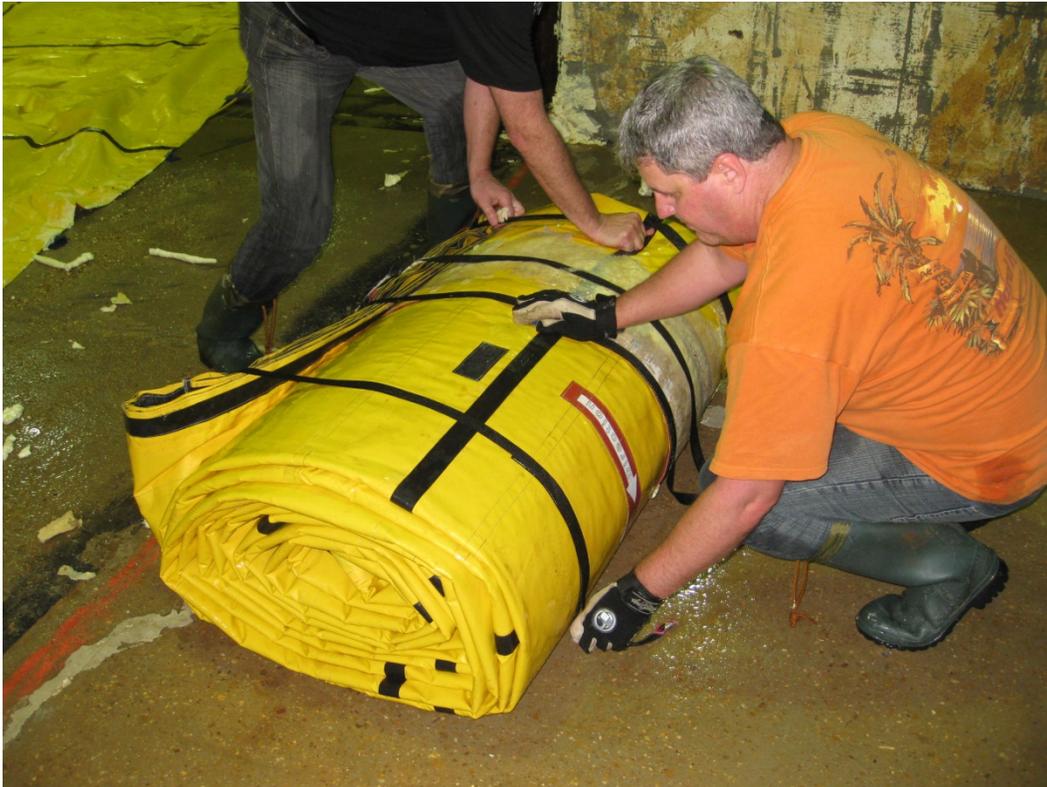
Figure 54. The barrier is rolled and will be packed into a carry bag.
